# Quality Home Inspections

## PROPERTY INSPECTION REPORT

Prepared For: David Heavener  
Concerning: 1402 Laurel Street  
City Georgetown State Texas Zip 78626

Inspection Date March 28, 2008

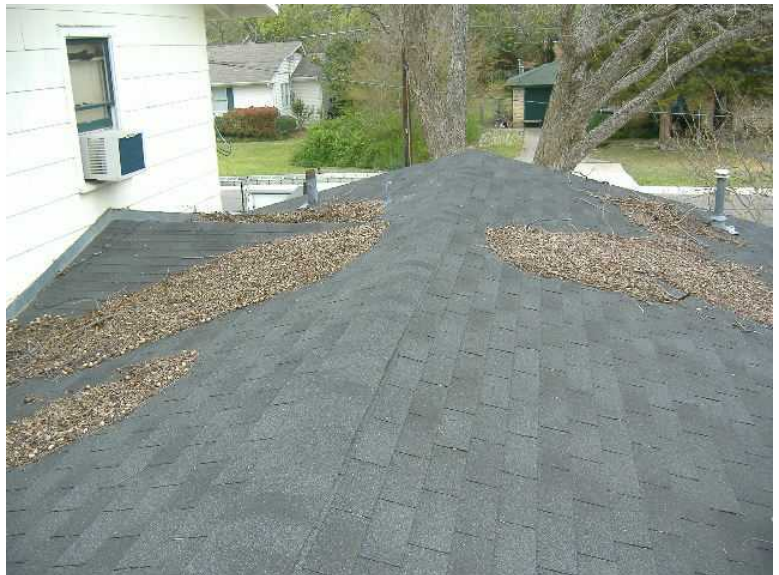
Signs of previous hail impact at the soft metal vents. No signs of hail damage to the shingles.

Granular surfaces of the ridge cap shingles for the second level are damaged.

Signs of a previous water leak at the plumbing vent stack for side B. Unable to determine if active.

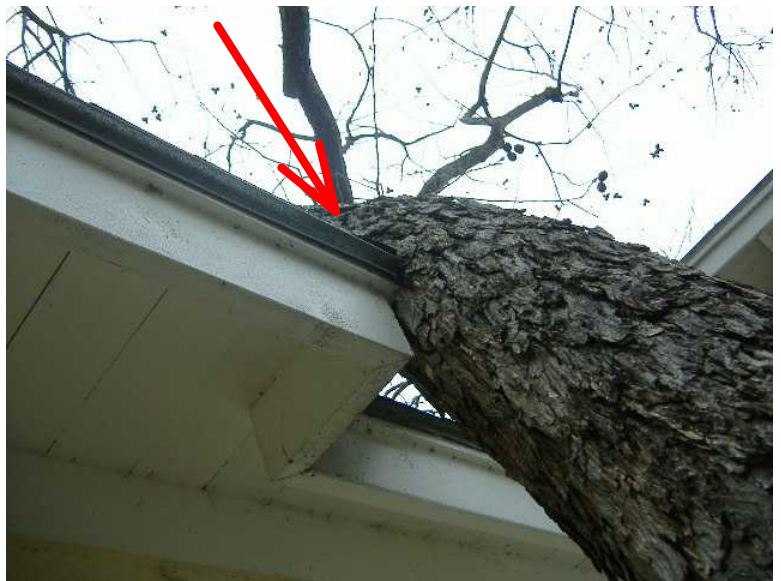
Large tree in contact with the roof structure; side A at the rear deck area.

Decking materials weathered and water damaged at the overhangs at various locations. Rafter tails at the overhangs are weathered and water damaged at various locations.

Attic has approximately 2" of insulation (Additional insulation recommended)

Ridge beam is not the correct size dimensional material. The beam does not span the entire width of the angle cut of the rafters. Collar ties are not installed. Roof structure appear to be stable in its current position.

Signs of a previous water leak at the plumbing vent stack. Unable to determine if active.

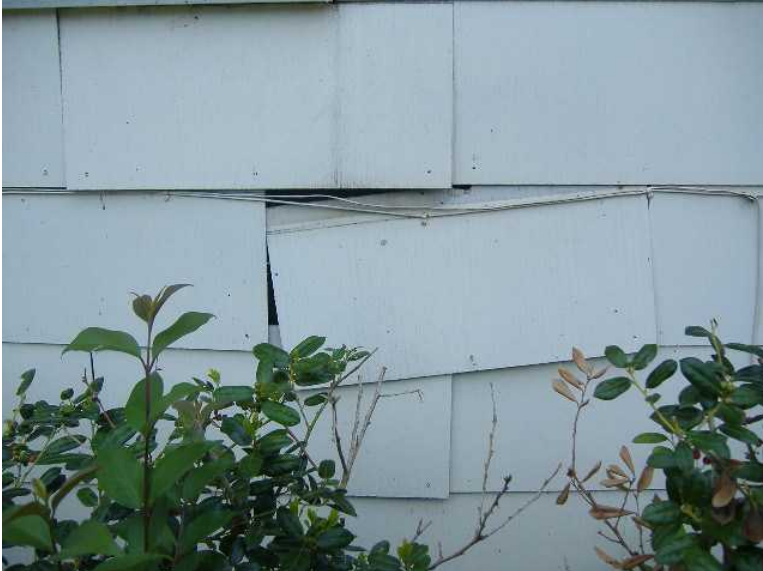
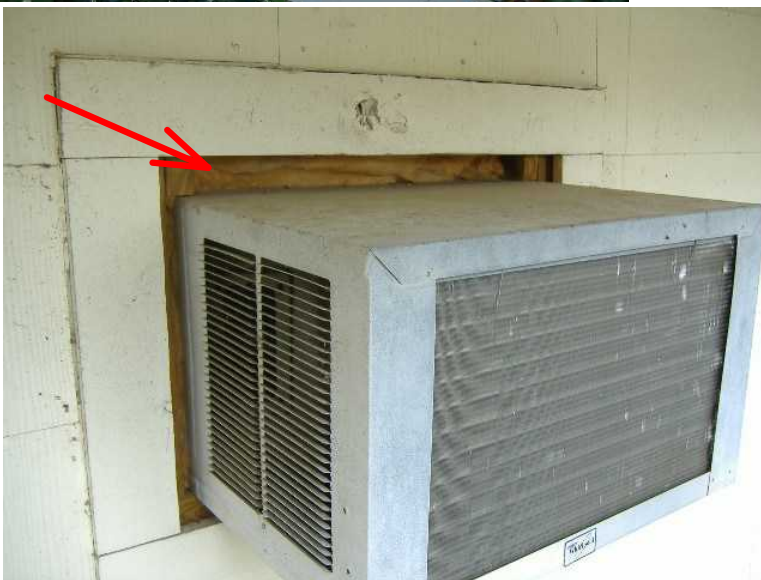
Exterior siding wall tiles are chipped and cracked at various locations.

Exterior siding wall tiles are loose at various locations.

Exterior trim is weathered and water damaged at various locations.

Settling cracks in the interior wall surfaces at various locations.

Large void in wall behind the oven; sheet rock incomplete; sheet rock needed to provide properly fire barrier.

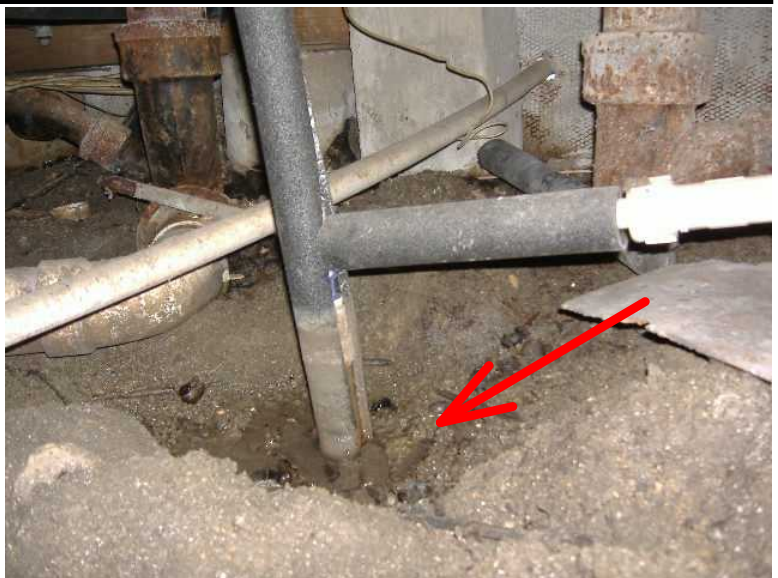
Appears to be a water supply leak under the structure in the crawl space area. Standing water in the crawl space at the time of the inspection.  
Galvanized piping has a known life expectancy of 50 to 60 years. Galvanized piping tends to corroded from the inside and damage cannot be seen.  
Water supply lines in the crawl space area are not insulated.  
No anti-siphon devices installed at the exterior spigots.

Water supply lines in the garage attic area to the water heater are not insulated properly.

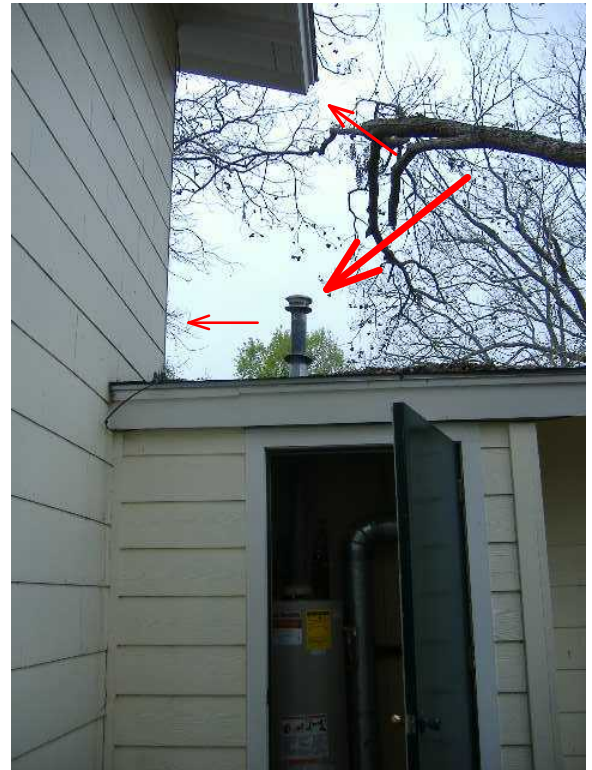
No combustion air ducts installed in water heater closet.

Water heater dated to 1978

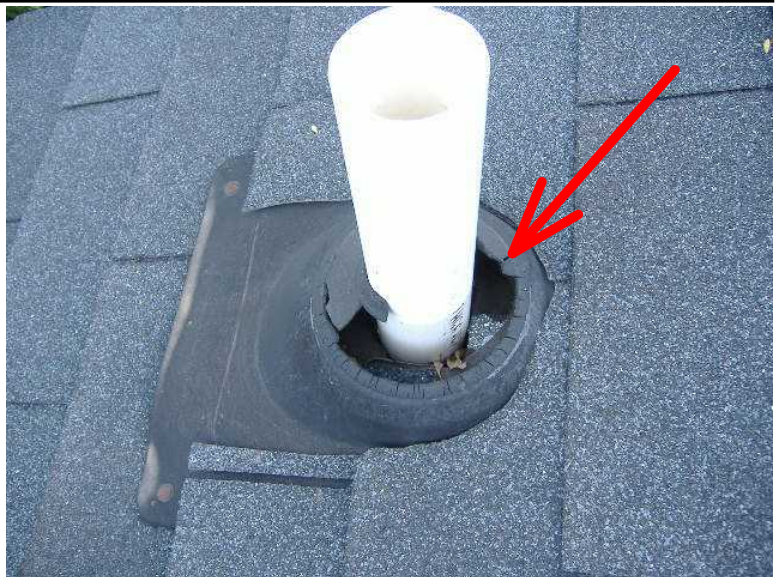
The plumbing vent stack weather boots are deteriorated and water entering the roof structure.

The sky light is cracked.

The foundation is too low or the soil grade around the structure is too high. There should be 6 inches of exposed foundation under the exterior siding.

The garage wall outlets are not GFCI protected.
