## PROPERTY INSPECTION REPORT

**Concerning:** 215 Avalanche Ave., Georgetown, TX 78628  
(Address or Other Identification of Inspected Property)

**By:** Jesse W. Bryant TREC#8511 Jan 28, 2011  
(Name and License Number of Inspector) (Date)

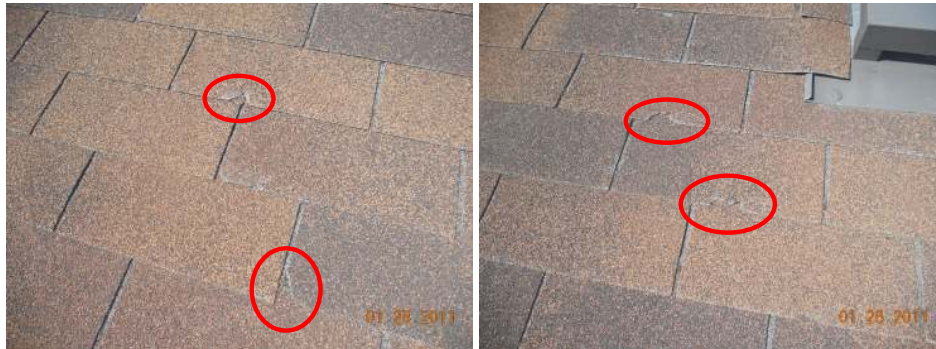
- o There are some slightly damaged shingles on the South slope (worn tab edges). At this time, the damage does not appear to be such that water penetration can occur and no signs of water penetration were noted in the attic. Repairs are recommended as necessary.

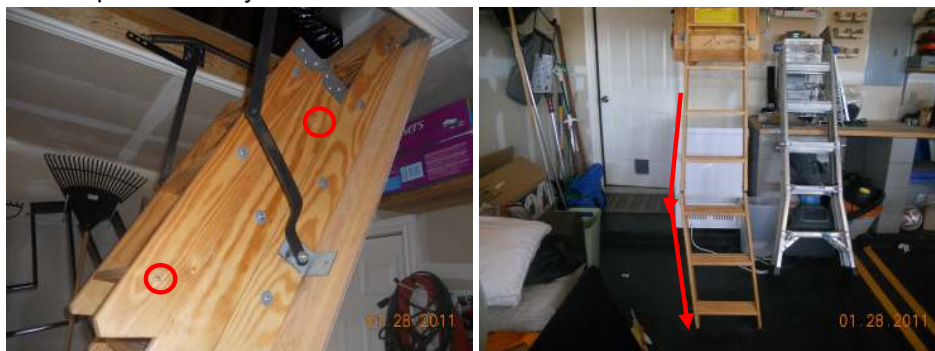
- Some of the attic stair unit hardware is missing (washers and nuts for some of the step rods) and the lower hinges are bent somewhat, which can cause the stair unit to not be completely stable during use. Repairs are recommended for improved safety

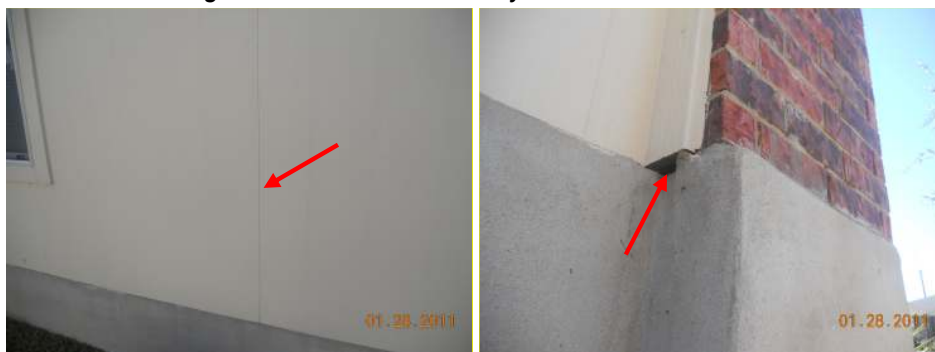
- *FYI: Protecting the home from possible water and insect penetration is very important. One way to achieve this is to ensure that all gaps and openings at the siding and brick exterior of the home remain properly sealed and caulked. Plumbing or other wall penetrations, gaps at the siding and brick joints and any visible points of entry should be properly sealed (with the exception of weep holes in the brick). Annual inspection and maintenance is also recommended as caulking/sealant materials can dry out and shrink over time.*

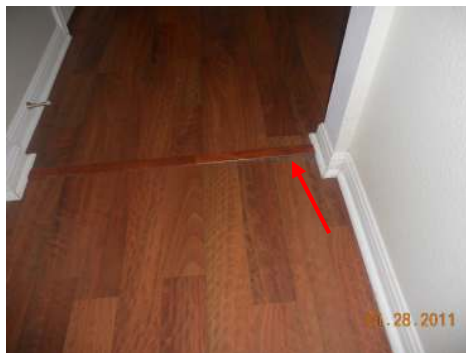
- The installation of the pull-down attic stairs in the garage compromises the fire separation barrier between the garage and the attic. Some type of removable panel, with an approved fire rated material, could be installed on the attic side of the attic stair unit, or the pull down stair assembly could be changed out to a fire rated model.
- Some of the wood transition strips are loose and some are missing (closets). Repairs are recommended in order to prevent potential trip hazards.

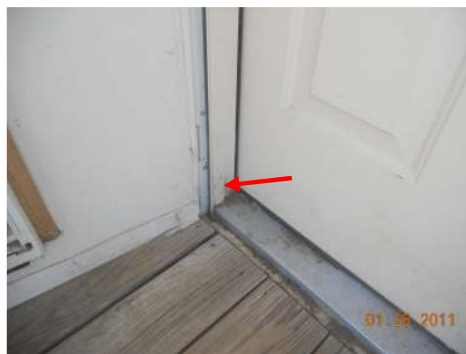
- There is evidence of previous water penetration and trim damage at the rear exterior door. This condition commonly occurs when water runoff from the roof splashes onto the door and jamb after impacting to the patio/deck surface. Once guttering or some other type of drainage diverter is installed over the eave over the doorway, it is recommended that the damaged sections of the door jamb material be repaired in order to prevent future water penetration.

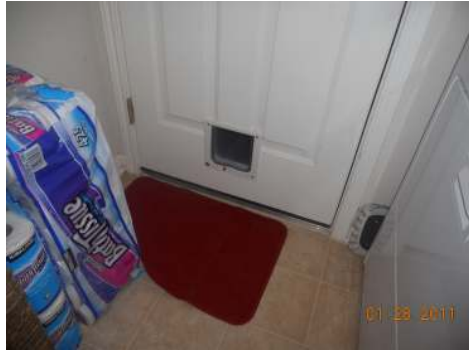
- The required fire separation properties of the garage entry door (between the garage and laundry room) have been compromised with the installation of the pet door. The door can either be repaired with the appropriate material or the door can be replaced with the proper door for this location (1-3/8" thick solid wood door, honeycomb steel door or any other 20 minute fire rated door).

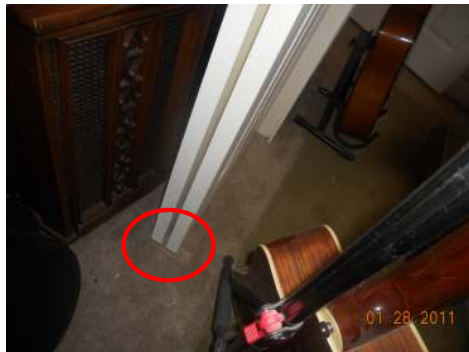
- The sliding closet door track guides are missing in the Southwest bedroom. The installation of a new track guide at the floor is recommended in order to prevent the doors from swinging or rubbing against each other during use.

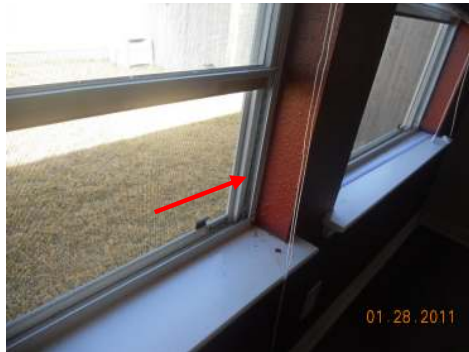
- There is a disconnected tension rod at one of the dining room windows. Repairs are recommended in order to allow the window to operate and stay open properly.

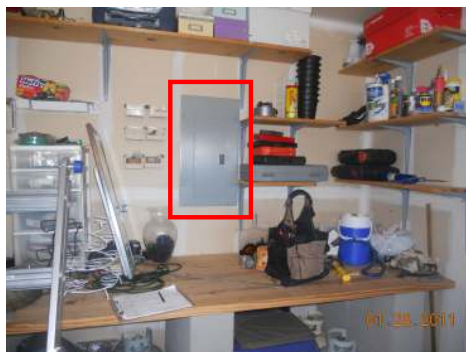
- There is inadequate clearance at the front and sides of the subpanel box in the garage. All electrical panel boxes should have a 36” deep by 30” wide by 6 ½’ high free area in front of the access. This clearance should be maintained for improved safety.

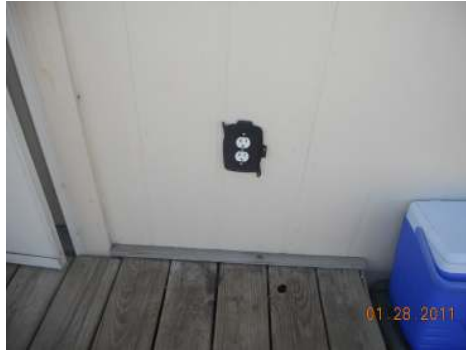
- The bubble cover for the rear exterior receptacle is missing and should be replaced in order to prevent possible water penetration into the receptacle.

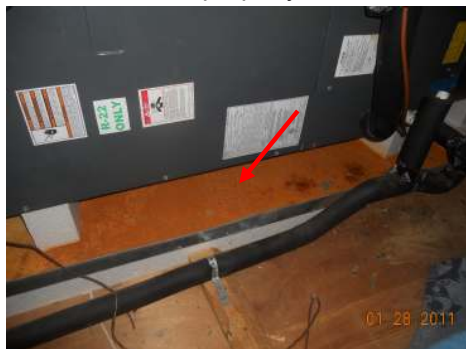
- The auxiliary drain pan installed below the evaporator coil unit in the attic contains a fair amount of rust. The rust and staining inside this pan suggests that the primary condensate drain line may have had a blockage or clog at some point in the past. No signs of current moisture were noted at this time and the blockage may have been removed during servicing or possibly even dislodged on its own. Testing and monitoring is recommended to ensure that the primary condensate line will drain properly.

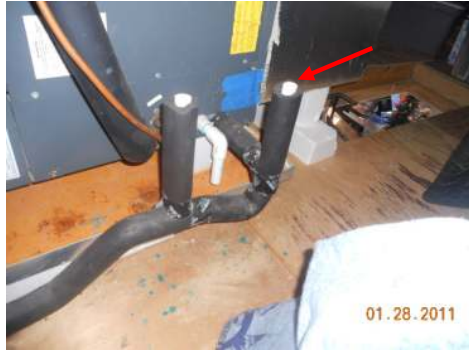
- The cleanout opening in the primary condensate drain line (prior to the trap) should be capped to ensure that the line will drain properly and that unfiltered air will not be pulled into the air handler unit. A removable cap is ideal so that the line can be accessed for periodic cleaning.

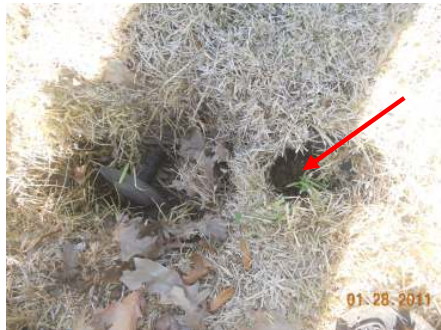
- The main water shut off valve is buried in the valve box. The soil in the valve box should be removed and the box should be re-positioned in order to provide access and to prevent damage to the valve.

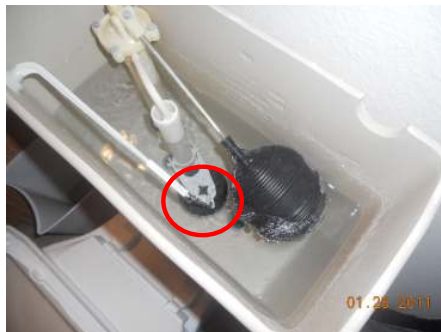
- The toilet tank flappers are no longer maintaining a good seal, which is causing the toilets to run constantly in order to maintain the water level in the tanks. New flappers are recommended for improved operation.

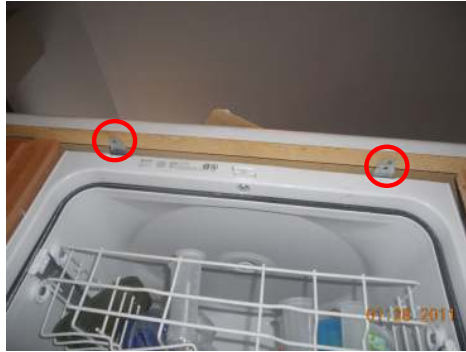
- The dishwasher is not secured well in the cabinet opening. Repairs are recommended.

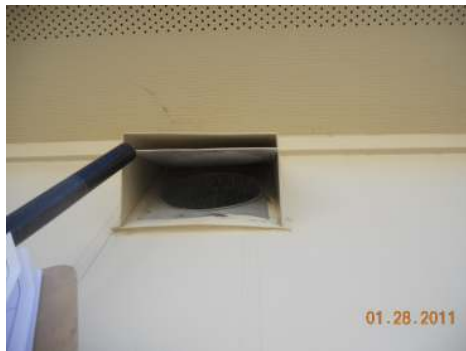
- Screening is recommended at the exterior portion of the range exhaust vent in order to prevent insect (wasps) or bird nesting.

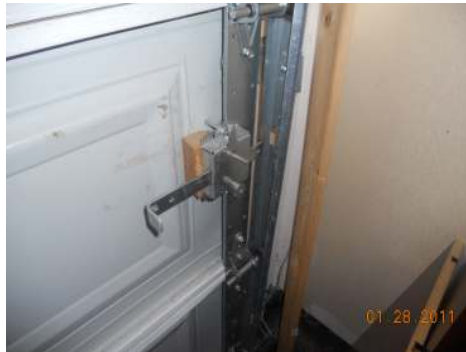
- The garage door locks should be removed or disabled in order to prevent accidental door/component damage from attempting to open the door with the operator, while the door is locked.
