PROPERTY INSPECTION REPORT

Concerning: 428 Hanover Ct., Georgetown, TX 78633
(Address or Other Identification of Inspected Property)

By: Jesse W. Bryant TREC#8511 Apr 20, 2011
(Name and License Number of Inspector) (Date)

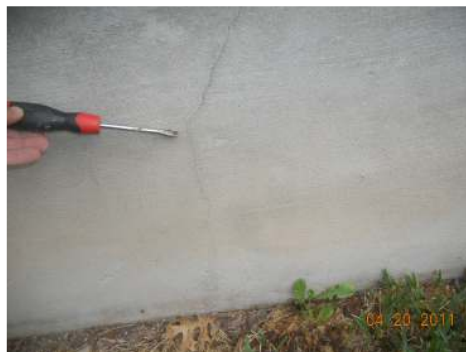
- FYI: A hairline crack was noted at the West grade beam surface. This crack, by itself, do not suggest serious structural issues with the foundation and is likely localized in the cosmetic parge coat applied to the surface of the foundation. However, this crack should be monitored for any future movement or increase in size. Some type of foundation maintenance plan should also be implemented in order to reduce the chance of potential foundation movement between wet and dry seasons. See Foundation Maintenance Notes below.

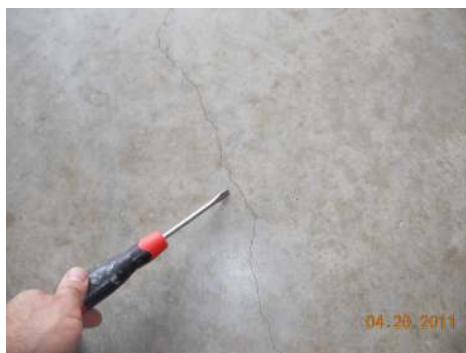
- FYI: Concrete shrinkage cracks were noted at the garage floor. These cracks are typically a result of material shrinkage that often occurs when the concrete cures and are typically about 1/8" inch wide or less. In my opinion, these small cracks do not suggest problematic foundation issues or failure, as there are no other visible indications or signs of differential foundation movement and/or structural deficiencies within the home.

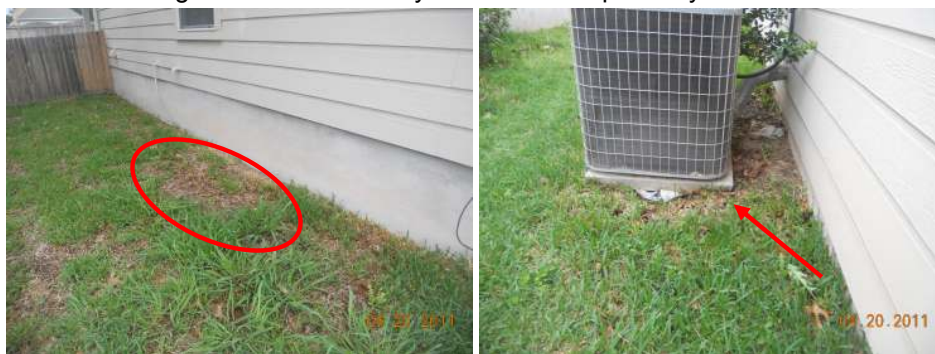
- The grading should be improved at the West side of the house as well as near the air conditioner condenser unit at the East side. The soil at these locations slopes towards the foundation somewhat and should be re-graded in order to promote the flow of storm water away from the house. This can usually be accomplished by the addition of top soil and/or sod. The ground should ideally have a 5% slope away foundation.

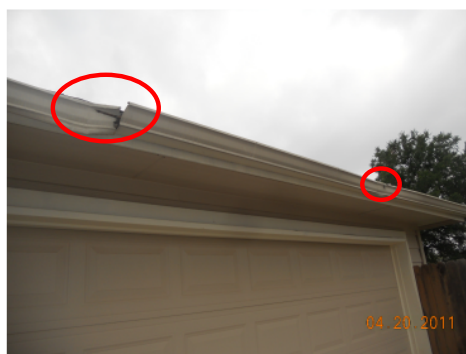
- The damaged gutters over the garage door should be repaired or replaced as necessary to avoid spilling roof runoff and improper drainage.

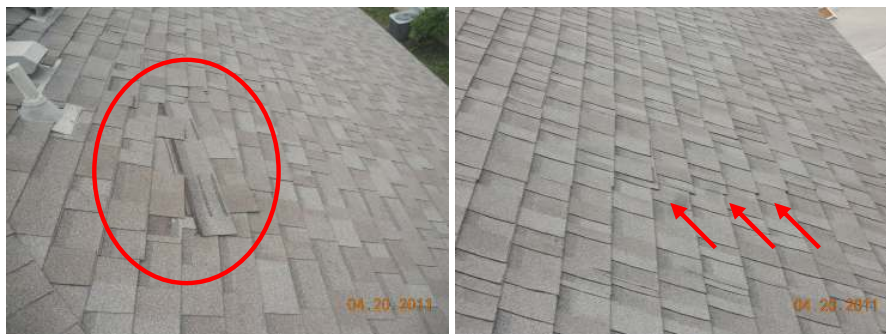
- There are some damaged shingles on the East and West slopes that are in need of repair in order to prevent potential leakage. The damaged shingles could be a result of detached fasteners. However, based on the combined areas affected, the shingles appear to be de-laminating and sliding; possible due to a manufacturing defect when the shingles were produced or improper installation. Further investigation and repairs are recommended.

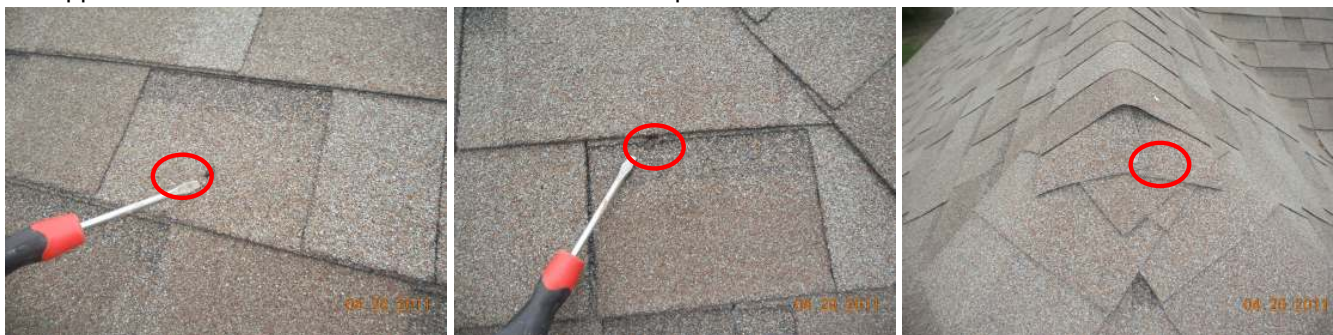
- Loosened nails that have protruded through the roof shingle surface were noted in various locations. At a minimum, the loose nail should be resecured or replaced and the damaged shingles should be sealed. Additional exposed nail heads at the flashings, roof penetration boots, ridge cap shingles, etc. should also be sealed with an approved sealant in order to reduce the risk of water penetration.

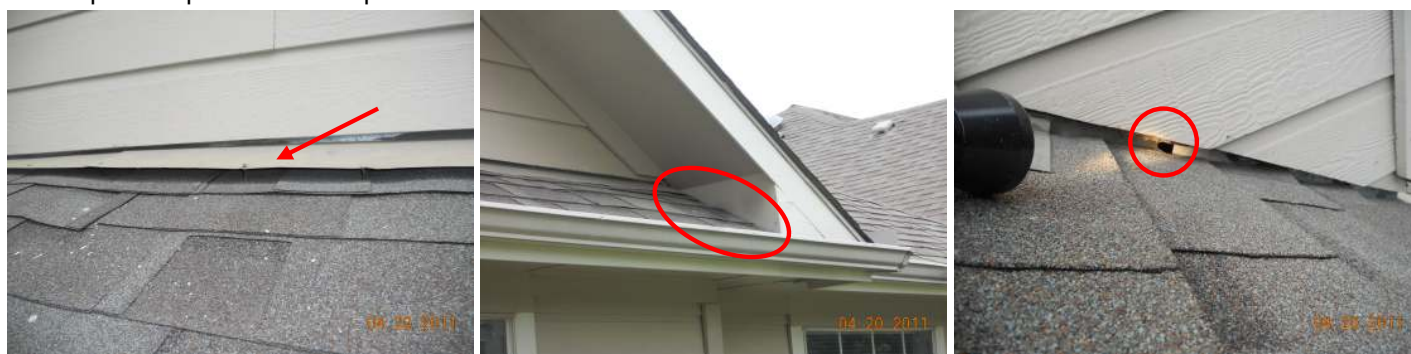
- Some of the roof-to-wall flashing has come loose at the front of the house and should be resecured. There is also some missing flashing at the East end of this area that could possibly result in water penetration into the soffit or even the wall. Lastly, there is a gap in the chimney step flashing. Flashing repairs are recommended in order to prevent possible water penetration at these locations.

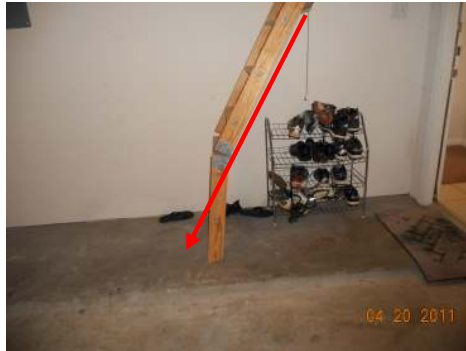
- Although the attic stair unit appears to be secure at this time, improper fasteners have been used to install the stair unit (sheetrock screws). As per the manufacturer's installation instructions, any fasteners other than 16D nails or 3" x 1/4" lag bolts are improper and not allowed. Repairs are recommended in order to comply with the manufacturer's guidelines.
- The attic stairs should be adjusted to relieve some tension so that the stair unit remains in the proper position without weight on the stairs. Repairs are recommended for improved safety.

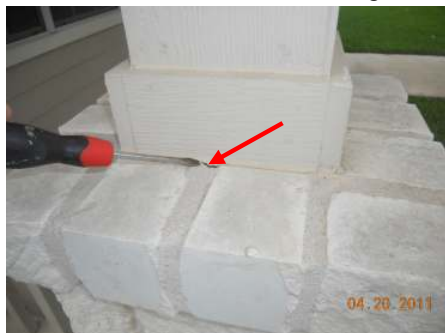
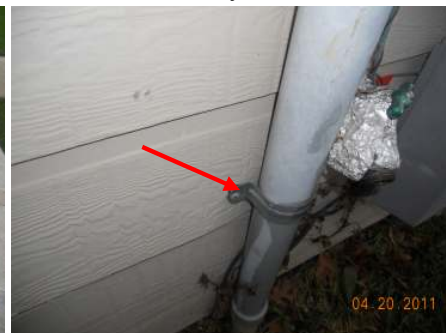
- Protecting the home from possible water and insect penetration is very important. One way to achieve this is to ensure that all gaps and openings at the siding and masonry exterior of the home remain properly sealed and caulked. Plumbing or other wall penetrations, gaps at the siding and masonry joints and any visible points of entry should be properly sealed (*with the exception of weep holes in the brick*). Annual inspection and maintenance is also recommended as caulking/sealant materials can dry out and shrink over time.

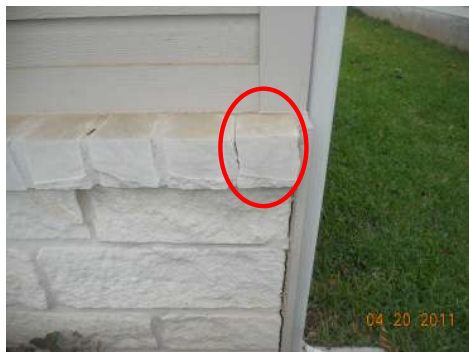
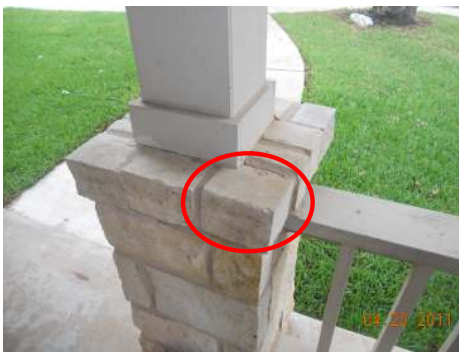
- There is a loose cap stone at the Southeast corner of the house as well as at one of the front porch posts. Repairs are recommended.

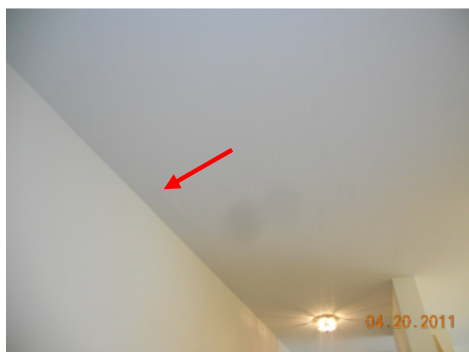
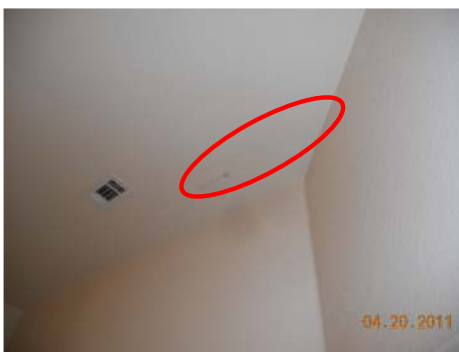
- Water staining and evidence of previous leakage was observed in the living room and master bathroom. The cause for the staining is believed to be from a previous leak at the evaporator unit in the attic; however, the exact cause should be determined and repairs undertaken, if necessary, to prevent further water staining and possible damage.

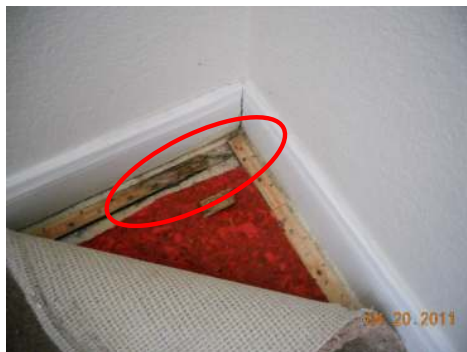
- The installation of the pull-down attic stairs in the garage compromises the fire separation barrier between the garage and the attic. Some type of removable panel, with an approved fire rated material, could be installed on the attic side of the attic stair unit, or the pull down stair assembly could be changed out to a fire rated model.
- Although no active moisture was observed at this time, there is evidence of previous moisture and fungal growth underneath a small section of the carpet at the Southwest corner of the Southeast bedroom. This may be a result of the missing flashing mentioned in the roof covering section (second picture in the flashing comment) or possibly even water penetration at the exterior wall. Once the flashing issue has been remedied and exterior wall gaps sealed, this area should be monitored for future water penetration.

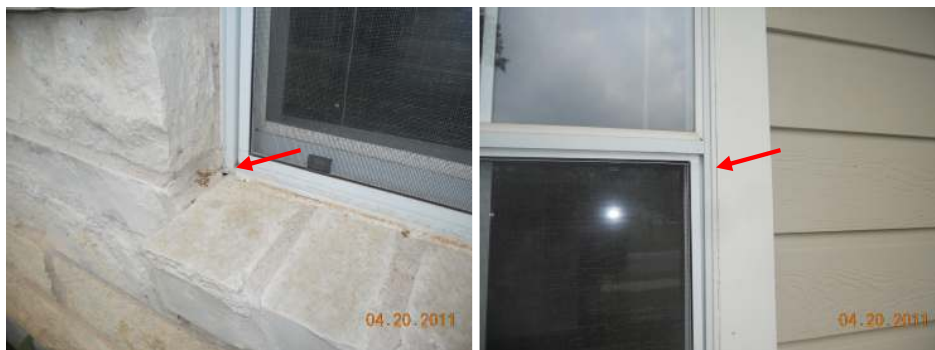
- Some of the window frames require additional caulking/sealant at the masonry ledges and wood trim. All gaps in the sealant or mortar around the window frames should be adequately sealed in order to prevent possible moisture penetration. The windows should be checked annually as the caulking material will dry out and deteriorate over time.

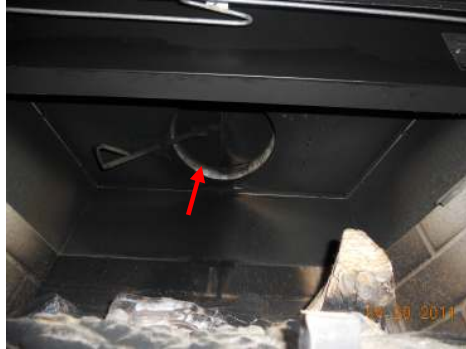
- The fireplace is gas log fireplace. Any time gas logs are present, it is recommended that some type of approved clamp be attached to the damper in order to maintain a 1” opening and prevent full closing of the damper at all times. This allows gas to escape through the flue rather than into the living space, in the event of a gas leak at the fireplace.

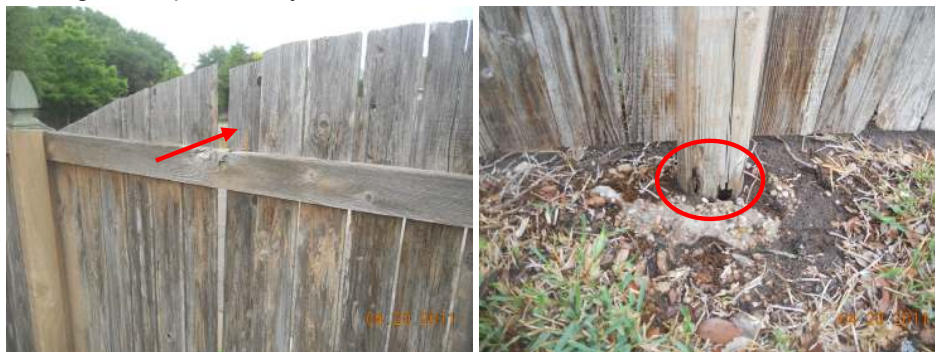
- There are some loose and damaged fence boards in various locations and some of the posts were observed to be rotting near the ground; particularly at the rear fence.

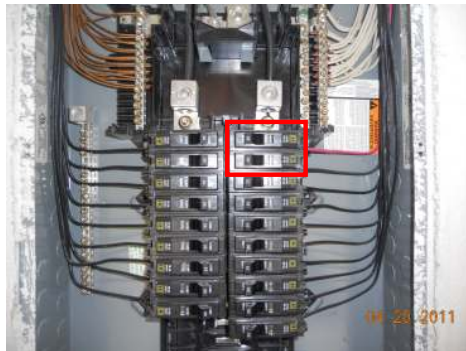
- Ideally, all multi-wire branch circuits should have a physical "trip tie" installed at the breaker switches (disposal/dishwasher in the sub panel). This simple device bonds the two circuit breaker switches together. This is a safety measure which protects people working on the circuit wiring and ensures that the multiwire circuit is installed properly at the panel (alternate poles). Using a trip tie ensures that if one leg of the circuit is being turned off for electrical repair work in the building, the other leg is forced off as well.

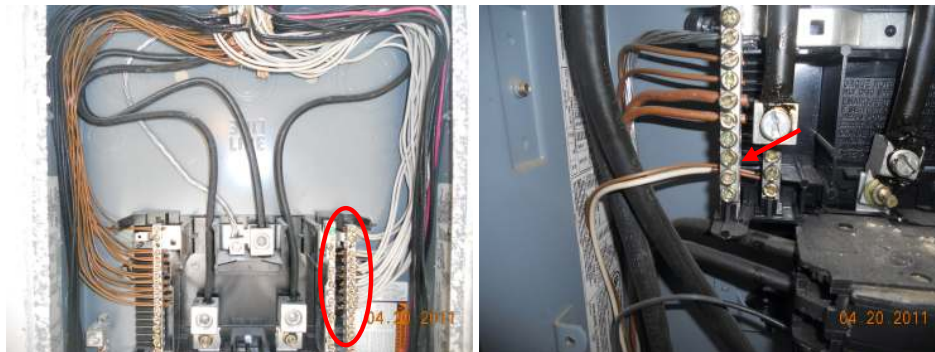
- The multiple neutrals that are combined under single lugs in the sub panel neutral bar should be separated and secured at individual holes in the neutral bar(s). There is also a ground wire and neutral wire secured under a single lug in the main panel box. Repairs will reduce the risk of loosening conductors and arcing inside the panel boxes.

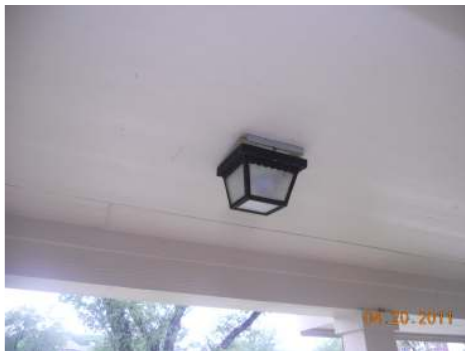
- Although it may not have been required at dedicated receptacles for fixed appliances when the home was constructed, every receptacle in the garage that does not have GFCI protection (ceiling receptacle for garage door operator) is to be marked as “deficient” as per the Texas Real Estate Commission’s (TREC) standards of practice for inspectors. GFCI receptacles offer additional protection from shock or electrocution (particularly in potentially wet areas) by monitoring the amount of current flowing from hot to neutral. If there is any imbalance in the flow, the GFCI trips. For more information on GFCI receptacles, visit http://www.guidedinspections.com/files/GFCI_Fact_Sheet.pdf
- The front porch light is loose and inoperative. Repairs are recommended.

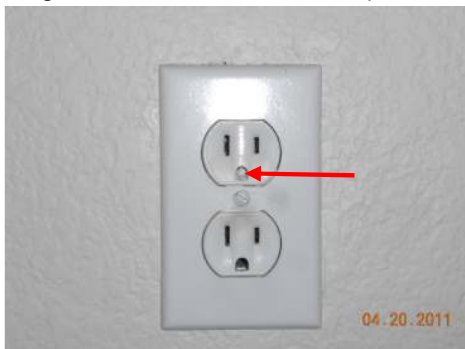
- There is an obstruction in the upper ground slot of the East receptacle in the master bedroom.

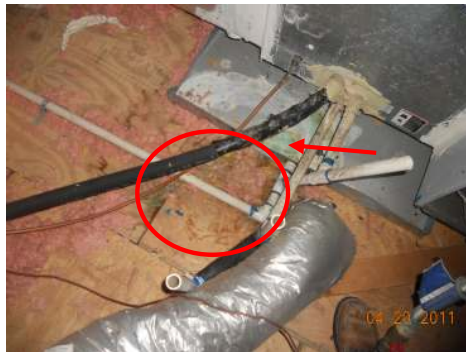
- Vegetation in the vicinity of the air conditioning condenser unit should be cut back to provide a 12" clearance around the condenser to allow proper air flow over the condenser coils.
- The emergency drain pan installed beneath the evaporator coil box shows signs of previous leakage and minor corrosion. This, combined with the evidence water staining on the wood decking in front of the pan, suggest that the emergency pan may have leaked in the past and may be in need of replacement. Further investigation and repairs, as necessary, are recommended.

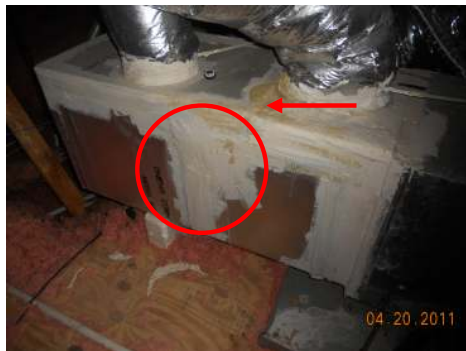
- Evidence of leakage was observed at various locations of the previously patched supply air plenum. Additional sealant and repairs are recommended in order to improve efficiency and to prevent condensation.

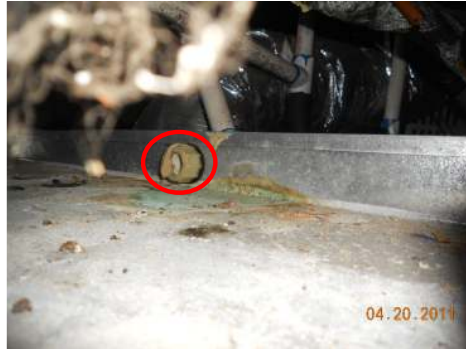
- There is a slight obstruction at the emergency drain pan drain line (mastic) that should be cleared to ensure proper drainage.

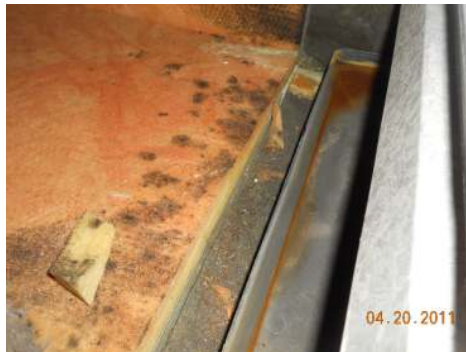
- Minor fungal growth was observed within the supply air plenum near the evaporator coil unit. Cleaning and servicing is recommended.

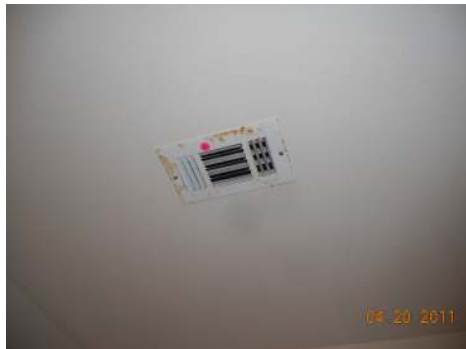
- The return air filters are dirty. This condition can decrease the efficiency of the heating/cooling systems by hampering the flow of air over the heat exchanger and evaporator coils. The filters should be changed regularly (every month is ideal) to improve air flow and efficiency.
- Some rust is present on the supply air register in the hall bathroom. This is typically a result of condensation that can form due to high humidity levels in the bathroom.

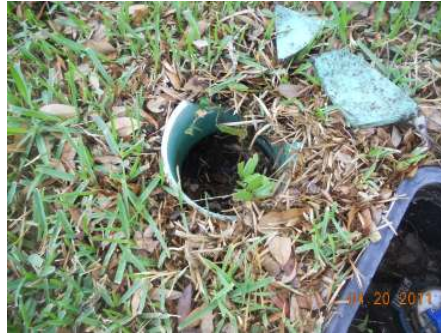
- The water shut off valve box is damaged, missing a cover and the shut off valve is slightly buried in the valve box. The soil in the valve box should be removed in order to provide access and to prevent damage to the valve, and a new cover should be installed.

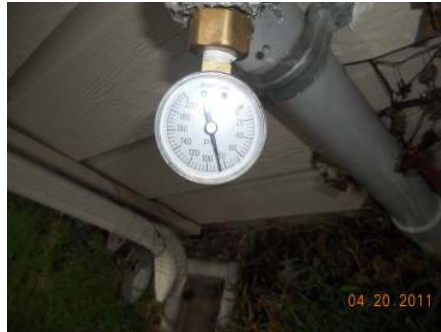
- The static water pressure of the supply plumbing system exceeded 80 pounds per square inch (psi) when tested. This pressure can vary throughout the day depending on neighborhood water use; however, if the sustained pressure remains over 80 psi through the day, it would be wise to install a pressure regulator device in the main water line. Otherwise, the plumbing system may be prone to leaks in piping, fittings or other equipment.

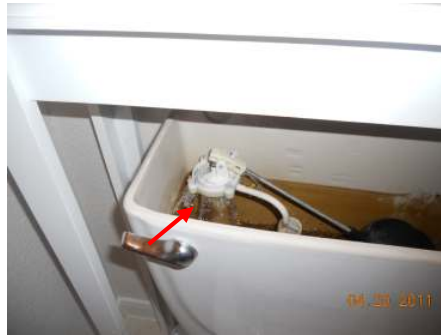
- The Southeast hose bib leaks at the handle when operated. This can usually be remedied by tightening the packing nut between the handle and the hose bib.
- The cold water faucet handle at the right sink in the master bathroom is missing a screw and loose.
- The upper ballcock valve gaskets in the toilets are worn and water is spraying out of the top of the valves when the toilets are flushed. If the water were to spray onto the underside of the tank lids, it could run out from under the tank lids, down the outside of the tanks and onto the floor. These gaskets can be replaced; however, it may be easier, and relatively inexpensive, to replace the valves themselves. The hall toilet also continues to attempt to fill the tank after flushed. The valve may need adjustment or the flapper seal may need to be replaced.

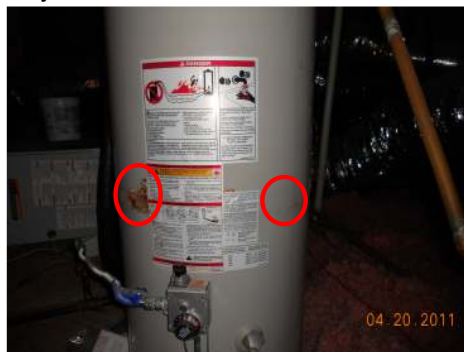
- Although no active leakage was noted, there is some rust on the exterior casing of the water heater tank. This may be a result of previous tank leakage or leakage from the water line connections at the top of the tank. Monitoring and repairs, as necessary, are recommended.

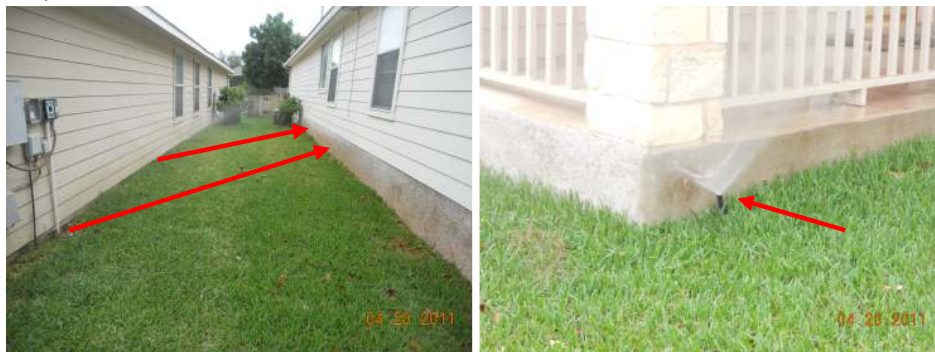
- No rain detection device was found during the inspection. It is recommended that a rain detection control device be installed and connected to the sprinkler system control box. When the sprinkler system is operating on an automatic schedule, this device helps prevent over saturation of the yard during periods of heavy rain.
- The water spray from some of the sprinkler system heads should be re-directed away from the structure, the neighboring house and/or any fencing, decks, etc., in order to decrease the possibility of water damage over time. Some of the heads also need to be adjusted in order to prevent excessive overspray onto the street and driveway; a significant waste of water. Some heads may simply require adjustment while others may need new spray pattern caps.

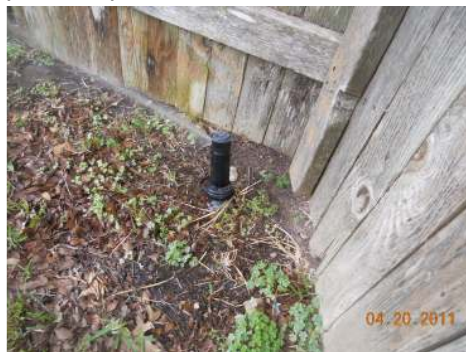
- Two of the rotor heads on zone 1 (along the West fence) appear to be damaged and not spraying properly. Repairs are recommended for improved operation.

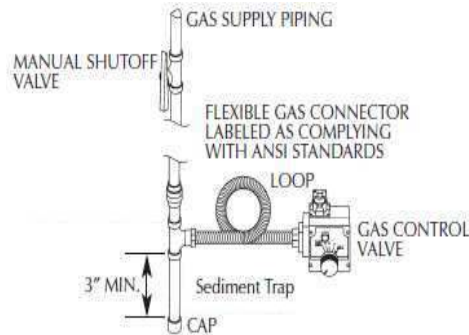
- A "sediment trap" is required for automatically operated gas appliance connections. Sediment traps are installed in the gas line, just before the appliance, and are designed to catch and hold any moisture or sediment inside the gas line that could possibly clog the gas appliance controls. There is no visible sediment trap at either of the automatically operated gas appliance connections at this time (water heater and furnace). Even if the local codes do not require these devices, most gas appliance manufacturers do require them as part of "proper installation" of their equipment. This should be investigated and repairs undertaken as necessary.
