PROPERTY INSPECTION REPORT

Concerning: 11416 Flushwing Dr., Austin, TX 78754
(Address of Inspected Property)

By: Jesse Bryant, Lic #8511 08/25/2011
(Name and License Number of Inspector) (Date)

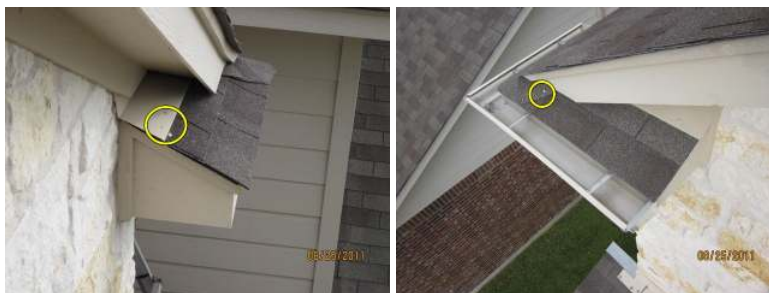
Exposed or lifting nail heads - Some exposed nail heads were observed at the upper gable returns, above the front porch roof. Exposed nail heads at the flashing, roof penetration boots, ridge cap shingles, etc. should be sealed with an approved sealant in order to reduce the risk of water penetration.

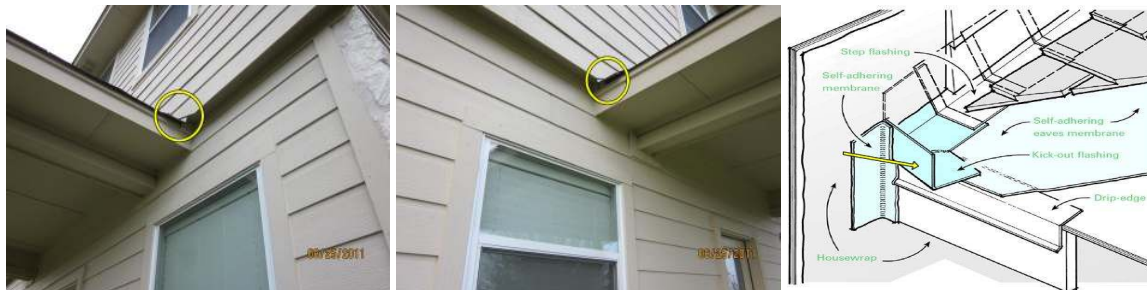
Flashing is lifting, ill configured, or missing - There is a small section of roof-to-wall flashing at the front porch roof that lifted due to loose nails. These nails should be re-secured and sealed in order to prevent possible water penetration.

Kickout flashing missing - In order to divert run off water away from the wall surface and any window ledges that may be below, some type of "kick out" flashing should be installed where the roof eaves terminate at a wall. This flashing detail can help prevent water penetration at doors and windows as well as staining at portions of the exterior walls.

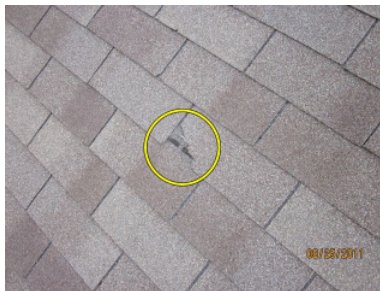
Damaged shingle - One of the shingle tabs on the South slope is damaged. Although this missing corner of the shingle tab does not appear to present a potential leak hazard at this time, repairs are recommended as necessary.

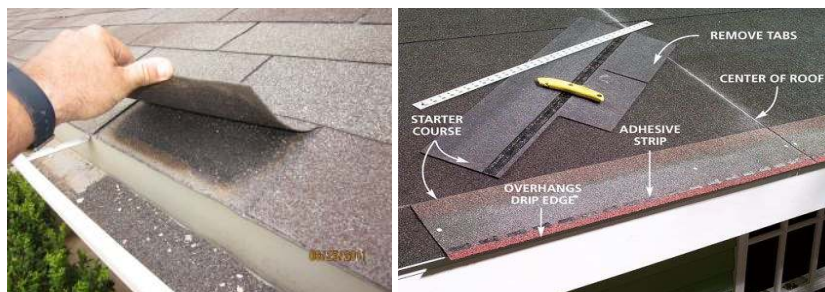
FYI: The shingle starter row has been installed improperly at the front porch roof eave. Typically, the starter row is supposed to have the seal down adhesive strip installed directly at the eave, with 4 - 6 nails securing each starter strip shingle. This method is required in order to prevent shingle uplift at the eaves during periods of high wind. Although no uplifted shingles were noted at this eave, it may be wise to eventually seal the first course of shingles to the starter row.

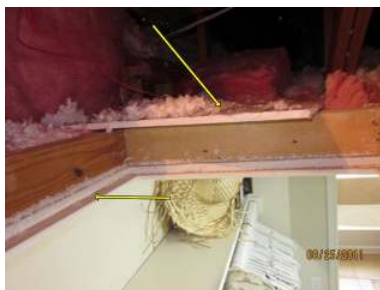
- Insulate / weather strip attic access - The attic access hatch in the master bathroom closet should ideally be insulated (fiberglass batt) and weatherstripped for improved efficiency.*

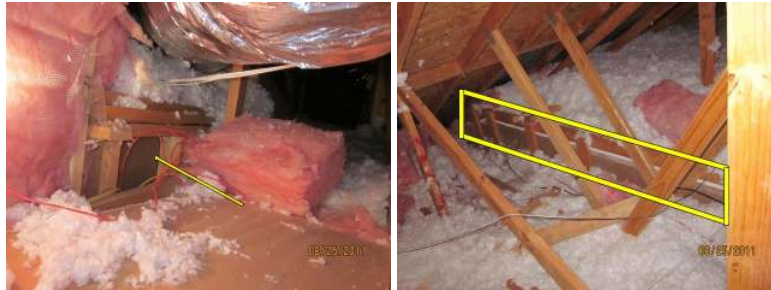
Evidence of insulation voids - There are some sections of the blown-in insulation that are compacted or insufficient (heavy traffic from previous work in the attic). There are also multiple sections of vertical insulation (vaulted ceiling for upstairs living room) that have been removed during wiring work, but were not put back in place; essentially leaving the sheetrock exposed in the attic. All loose sections of vertical insulation should be re-secured. Ideally, any area of sparse or compacted blown-in insulation (especially 6" or less) should be addressed by adding more insulation for improved efficiency over time.

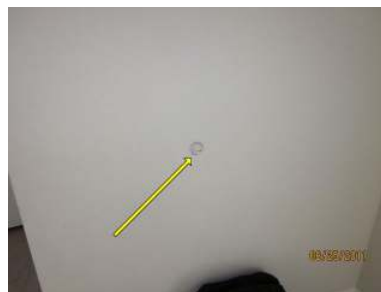
Sheetrock damage - There is a sheetrock hole in the foyer where the front door knob has damaged the sheetrock. Once sheetrock repairs have been performed, the installation of a door stop should be considered in order to prevent further damage.

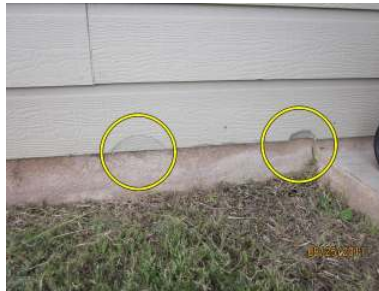
Damaged siding - The bottom course of siding, near the rear patio, is damaged. The damaged section does not appear to present a water penetration issue; however, repairs are recommended as necessary.

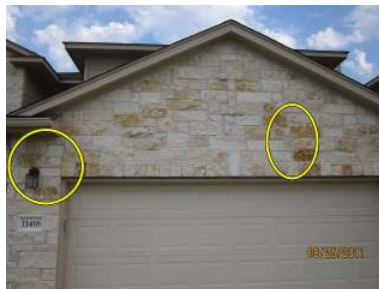
FYI: Typical mortar cracking was observed at sections of the masonry above the garage door opening. This type of mortar cracking is not uncommon at this location and typically occurs when the beam and lintel that support the masonry, sag slightly over time. The cracks observed to not suggest serious structural issues, but should be monitored.

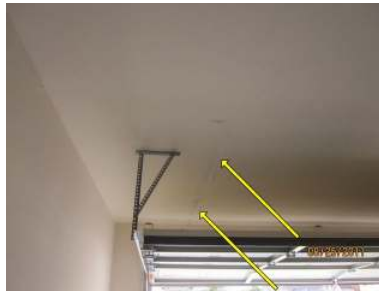
Evidence of leakage - There is evidence of previous leakage at the garage ceiling. The damage appears to be the result of a previous leak at the garage roof where a satellite dish was once located. The leak likely occurred after the dish was removed, but before the remaining holes were patched. The roof holes have since been patched at the shingles as well as at the decking in the attic and no signs of active leakage were noted at this time. At a minimum, it is recommended that the missing sheetrock joint tape be replaced in order to maintain the proper fire separation barrier between the garage and the attic.

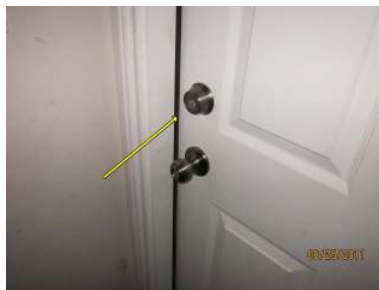
Gaps at weatherstripping seal - Small gaps were noted between the garage entry door and the weatherstripping surrounding the door. Adjustments / repairs are recommended in order to ensure that no possible garage fumes are allowed to enter the living space.

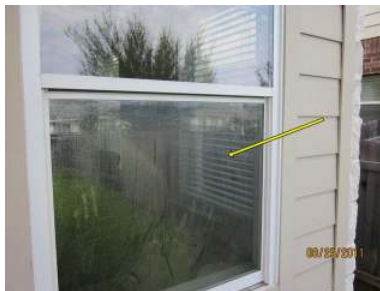
Hazy surface - There are some windows on the West wall (breakfast area, living room,

upstairs family room) that have a surface haze / discoloration; specifically on the lower portions of the windows, behind the screens. At first glance, these windows appeared to have lost their thermal seal. However, upon closer inspection, it appears as if some type of film has developed on the exterior portion of the windows. The film did not wipe off easily, if at all, and effective cleaning options will have to be explored.

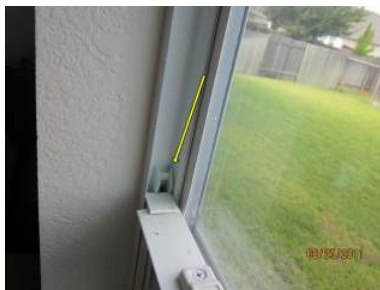
Some window lift supports are loose, damaged or missing - The Northwest living room window has a damaged / detached window lift support. Repairs are recommended for improved operation.

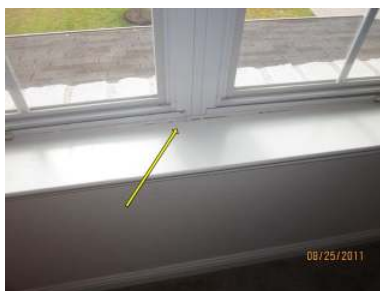
Caulk window at interior - Sealant is recommended between the window frame and the window sill, in the Southeast bedroom, in order to help prevent potential drafts.

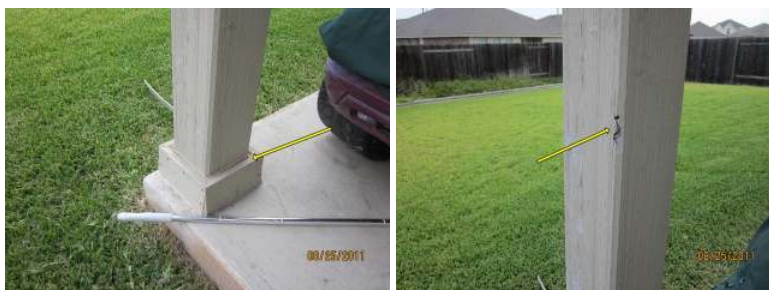
Caulk / paint posts - The gaps and cracks at the back porch support posts should be sealed and / or painted in order to prevent possible water damage and deterioration over time.

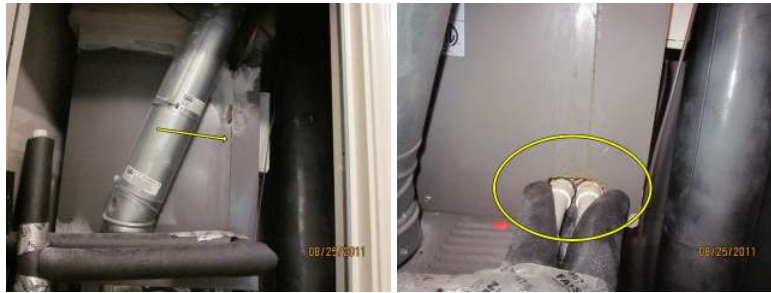
Air leakage noted at evaporator unit - There is a considerable amount of cool air that is escaping from the evaporator coil unit, particularly where the condensate lines pass through the housing as well as at the cover seam. This condition will result in inefficient operation and can create condensation that will drip down into the furnace unit. These areas should be properly sealed in order to prevent cool conditioned air from escaping. The cleanout opening in the primary condensate line (before the traps) should also be capped in order to prevent air loss. Repairs are recommended in order to prevent condensation improve overall unit efficiency.

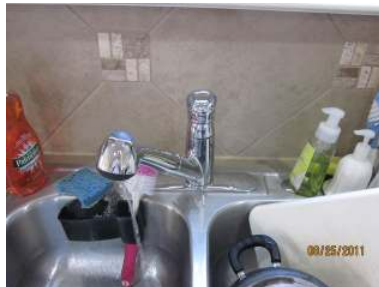
Loose or damaged faucet handles - The kitchen sink faucet leaks when the faucet handle is left in the center "off" position. Repairs are recommended as this faucet likely has a bad O-ring seal.

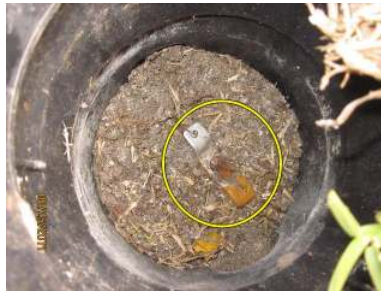
Soil around main shutoff valve - The soil around the main shutoff valve should be cleared away somewhat in order to provide full access to the valve so that it may be turned off quickly in case of an emergency. There is an excessive amount of soil in the adjacent valve box which is believed to house the pressure regulator device. This soil should also be removed from around the regulator device in order to provide access and to prevent possible damage.

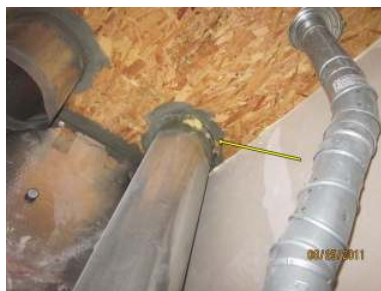
Loose combustion air vent pipe - The lower combustion air vent pipe in the water heater / furnace closet is loose at the ceiling and should be re-secured and sealed in order to allow proper combustion air circulation.

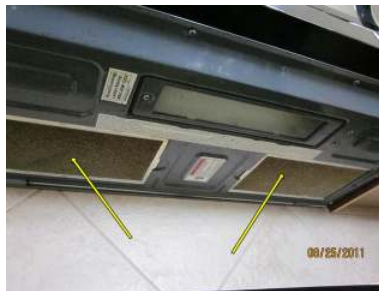
Filter is dirty / greasy - The filter screens at the range vent are very dirty and in need of cleaning or replacement.

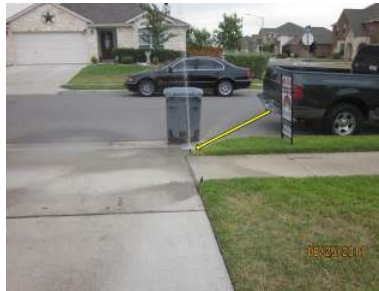
Damaged sprinkler head - There is a broken sprinkler head on zone 2, where the sidewalk and driveway meet. Repairs are recommended.

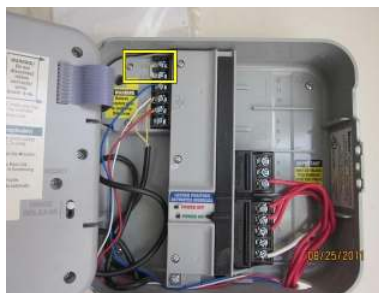
The lack of a rain sensor - No rain detection device was found during the inspection. It is recommended that a rain detection control device be installed and connected to the sprinkler system control box. When the sprinkler system is operating on an automatic schedule, this device helps prevent over saturation of the yard during periods of heavy rain.

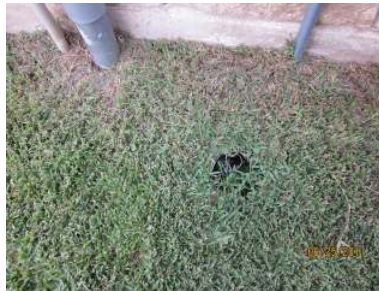
Valve box cover missing - One of the sprinkler valve boxes at the Northeast corner of the house is missing a cover. Replacement is recommended in order to protect the valve and prevent a possible trip hazard.

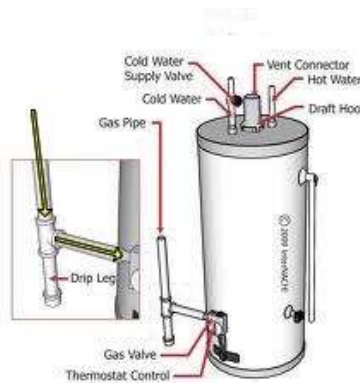
Improper sediment trap installation - The sediment traps installed at the furnace and water heater are not installed properly in that there is no change of direction in the gas lines at the sediment traps. Modifications are recommended in order for the sediment traps to operate effectively in the future.

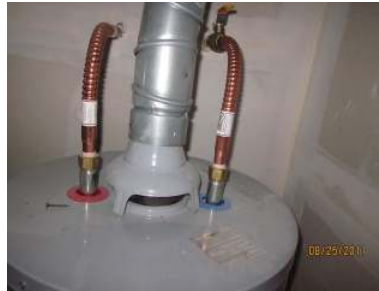
Draft hood / vent pipe not secure - The draft hood at the top of the water heater has been positioned in place during installation but was not secured. The draft hood should be secured to the water heater tank, with mechanical fasteners, to ensure that the vent pipe does not come loose.
