## PROPERTY INSPECTION REPORT

**Prepared For:** Jon Hopkins  
(Name of Client)

**Concerning:** 122 Summers Green, Georgetown Texas 78633  
(Address or Other Identification of Inspected Property)

**By:** Ken Cofer # 20262 09-22-11  
(Name and License Number of Inspector) (Date)

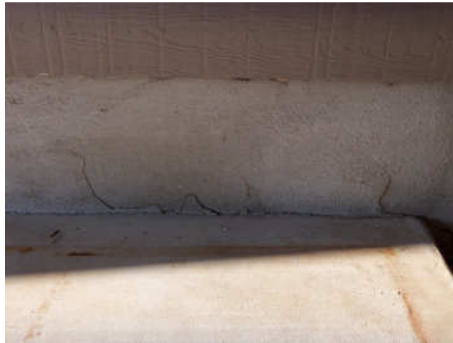
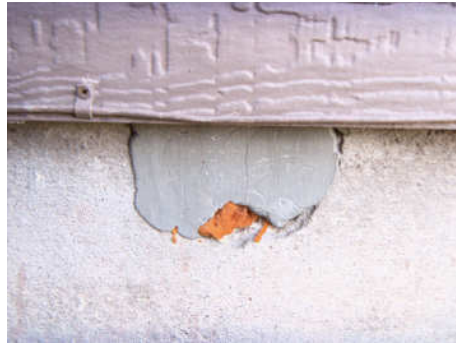
*Comments:* Surface deterioration (known as spalling) was observed on the exterior of the exposed foundation walls along the north side of the house. This condition is common in many homes and does not usually represent a structural concern. In an effort to prevent long term deterioration, it would be wise to consider parging deteriorated areas. Lot drainage improvements, as outlined in the "Exterior" section of this report are also recommended. Evidence of previous repair to west side of foundation. In this inspectors opinion the foundation is functioning as intended.

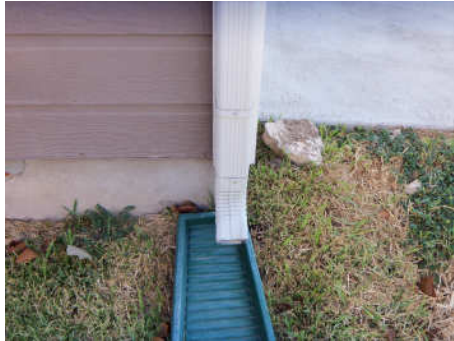
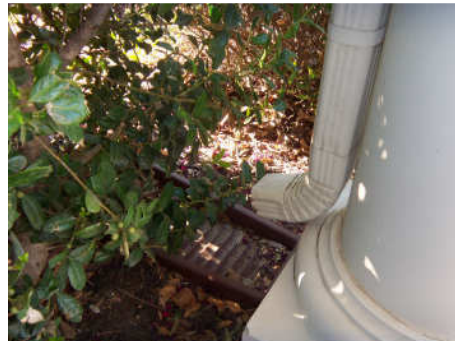
**B. Grading & Drainage** *Comments:* Recommend installation of gutters where not present to better control rain runoff to lower roof levels to minimize premature aging of the shingles. Gutter downspouts draining too close to structure.

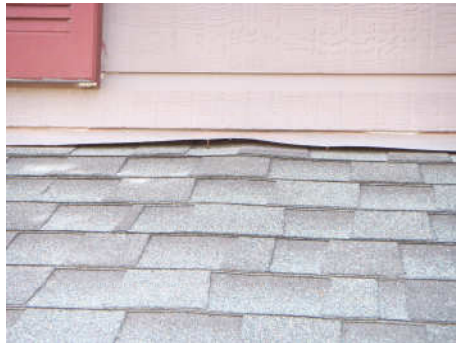
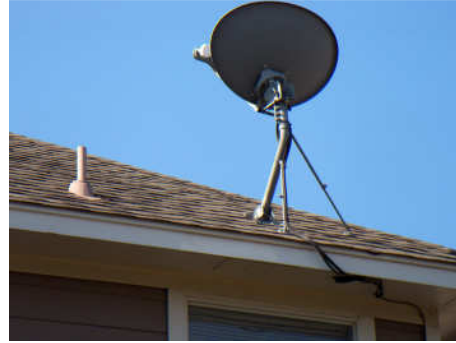
*Comments:* Nail heads are exposed at the flashing at the south slope. They should be sealed to reduce risk of leaks. Satellite dish installed directly to roof surface at the northwest corner. Possible water penetration.

Nail heads are exposed at the flashing at the south slope. They should be sealed to reduce risk of leaks.

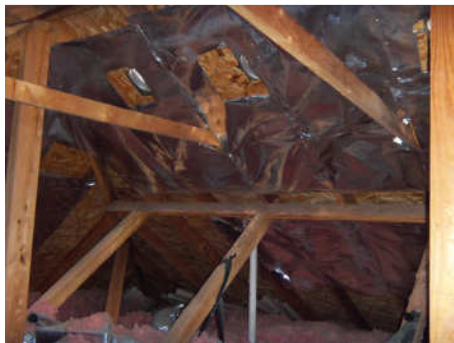
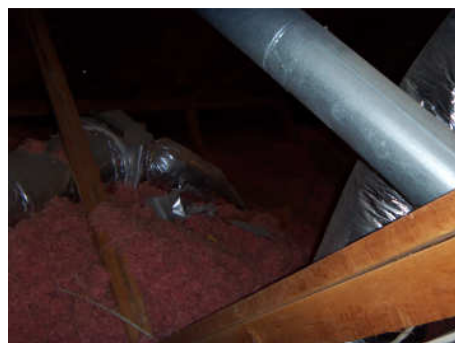
*Comments:* Unable to inspect majority of roof decking and rafters due to previously installed radiant barrier type material attached to bottom of rafters. Unable to determine if all required soffit baffles are in place to assist in proper convection ventilation. Insulation improvements in many locations may be cost effective, depending on the anticipated term of ownership. Compressed insulation due to HVAC ducts laying on insulation should be rearranged.

Insulation improvements in many locations may be cost effective, depending on the anticipated term of ownership. Compressed insulation should be rearranged.

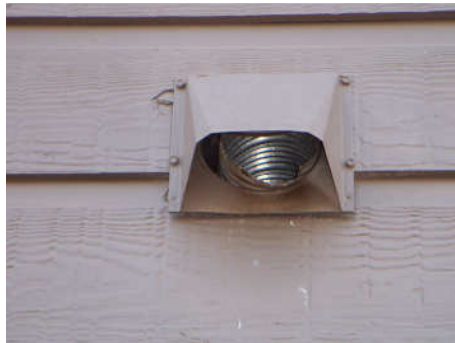
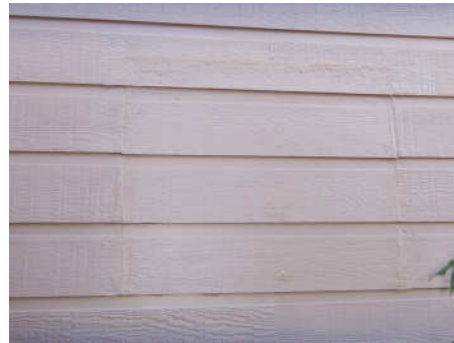
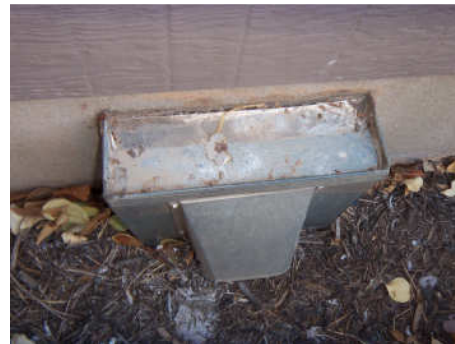
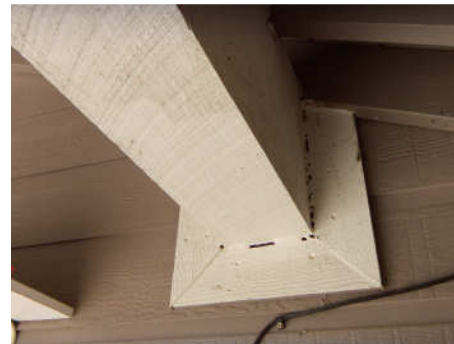
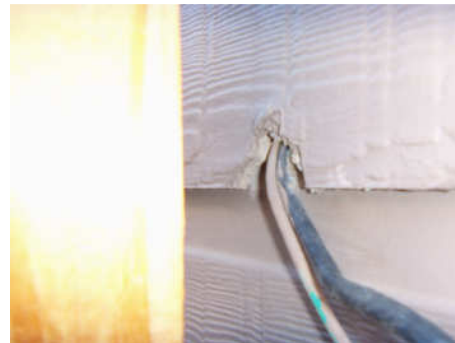
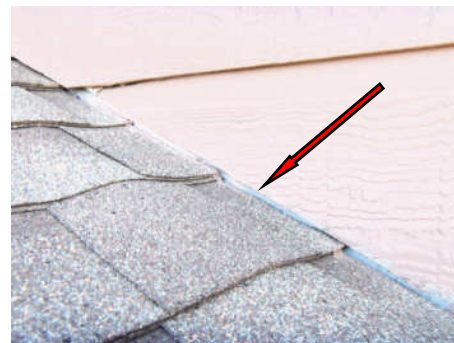
**E. Walls (Interior & Exterior)** *Comments:* Minor cracks were noted on interior walls in various locations. This condition is mainly cosmetic in nature and should be patched. **TREC LIMITATIONS:** The inspector is not required to report cosmetic damage or the condition of floor, wall, or ceiling coverings; paints, stains, or other surface coatings; cabinets; or countertops, or provide an exhaustive list of locations of water penetrations. Caulking or sealant separated or missing in multiple areas regarding the exterior siding, around penetrations such as vents, electrical wiring, window frames, light fixtures and hose bibs. Facia/trim boards are water damaged in several areas. Vent penetration requires weather protection in the form of a damper as well as 1/4" to 1/2" mesh screen at termination. Exterior cement board siding does not comply with manufacturers installation guidelines on south side of structure. Manufacturer requires a minimum 2" separation from bottom edge of siding to roofing. Indication of water penetration and damage to the gable vent and window frames on south side of structure. Soffit vent on eastside of structure appears to be loose.

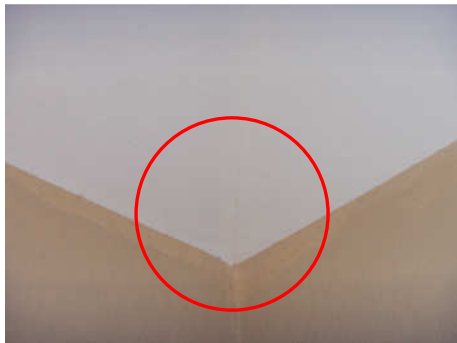
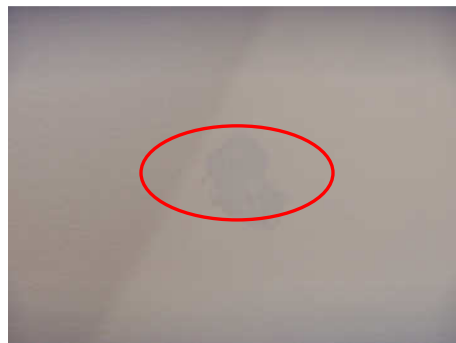
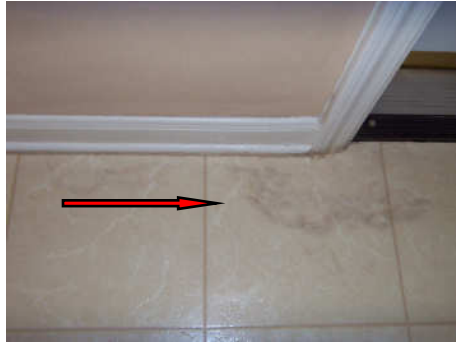
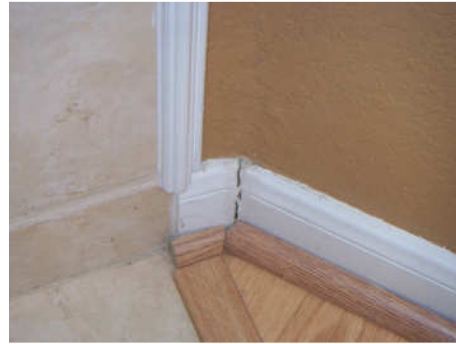
**F. Ceilings & Floors** *Comments:* Evidence of patching was detected in the south west bedroom on 2<sup>nd</sup> floor. Water staining was noted in the dining room. The cause for the staining should be determined and repairs undertaken, if necessary, to prevent structural damage.

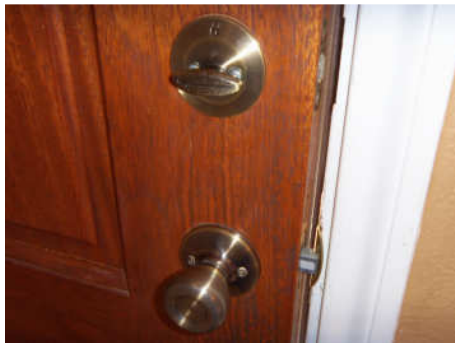
**G. Doors (Interior & Exterior)** *Comments:* Damaged or non-functional door hardware at the front of the house should be repaired. Door appears to be slightly warped thereby not making full contact with the door frame seal. The master bathroom shower door requires safety glass; the safety glass etching is not visible. The overhead garage door requires adjustment for easy and safe operation.

The overhead garage door requires adjustment for easy and safe operation.

Damaged or non-functional door hardware at the front of the house should be repaired.

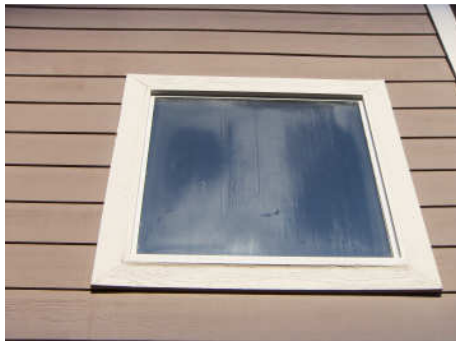
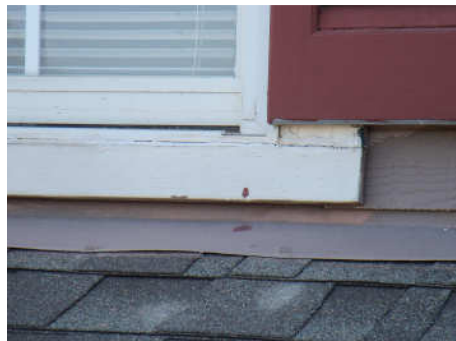
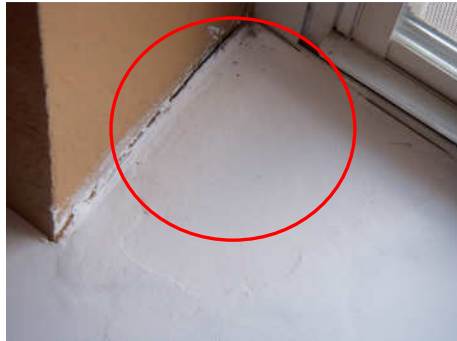
**H. Windows** *Comments:* The window(s) along the east side of the house have lost their seal. This has resulted in condensation developing between the panes of glass and can cause the glass to lose its insulating properties. The glass should be repaired or replaced. Sash cords (the ropes that hold up the windows) are missing on windows in the 2<sup>nd</sup> floor south west bedroom. Re-installation is necessary to ensure proper operation of the window. Indications that appear to be previous water damage to the exterior window frame in the 2<sup>nd</sup> floor southwest bedroom and window sill in living room. The two windows at the top of the stairs require safety glass and window guards. The three windows in the master bedroom require safety glass and window guards.

The window(s) along the east side of the house have lost their seal. This has resulted in condensation developing between the panes of glass and can cause the glass to lose its insulating properties. The glass should be repaired or replaced.

Sash cords (the ropes that hold up the windows) are missing on windows in the south west bedroom. Re-installation is necessary to ensure proper operation of the window.

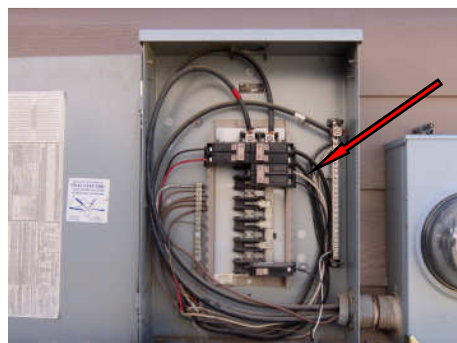
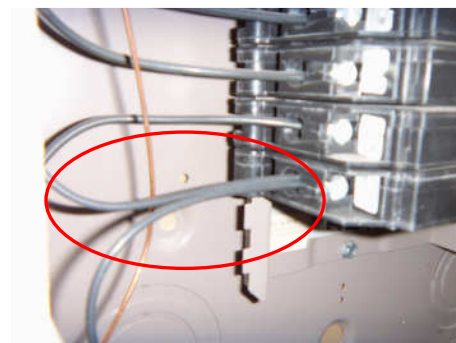
**A. Service Entrance and Panels Comments:** The main distribution panel along the west side of the house is undersized. It should be replaced with a panel that is suitable to the size of the incoming service. Any openings in the main panel should be covered. The main distribution panel did not have a main disconnect. This item should be repaired. There is one neutral white conductor being used as a hot conductor. This conductor requires red tape. No GFCI's or AFCI's present in Main Service or sub panels. Insufficient labeling in Main Service panel. Circuits within the sub distribution panel at the garage that are doubled up (referred to as "double taps") should be separated. Each circuit should be served by a separate fuse or breaker.

The undersized main service box along the west side of the house should be replaced, unless it is approved by the local electrical utility.

The main distribution panel along the west side of the house is undersized. It should be replaced with a panel that is suitable to the size of the incoming service.

Circuits within the main distribution panel at the garage that are doubled up (referred to as "double taps") should be separated.

Each circuit should be served by a separate fuse or breaker.

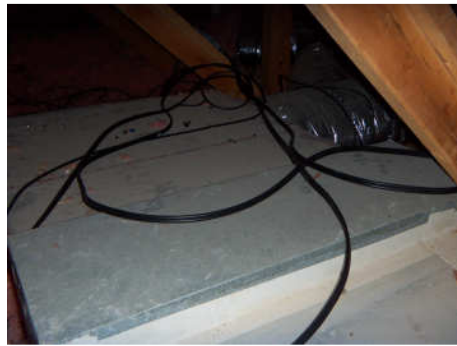
*Comments:* The furnace was inaccessible and could not be inspected. Current building code requires a minimum 30" x 30" platform in front of firebox. Existing platform is less than 24" in depth. Accessing the firebox could not be done safely. A small portion of the firebox was visible through the furnace combustion air vents, where the flame in the burner tubes appeared to be primarily blue with intermittent yellow flames which are usually caused by lack of combustion air. However, it can also indicate dirty or clogged burners or a heat exchanger issue. Presence of what appears to be low voltage wires/cables lying on plenum.

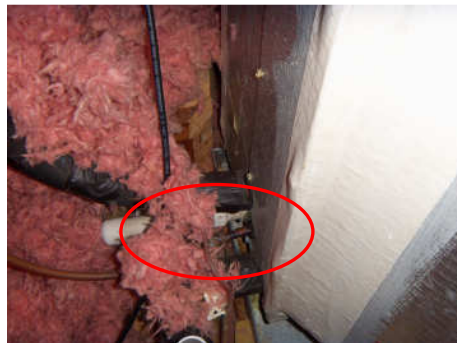
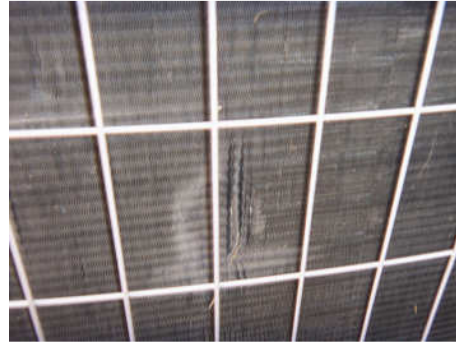
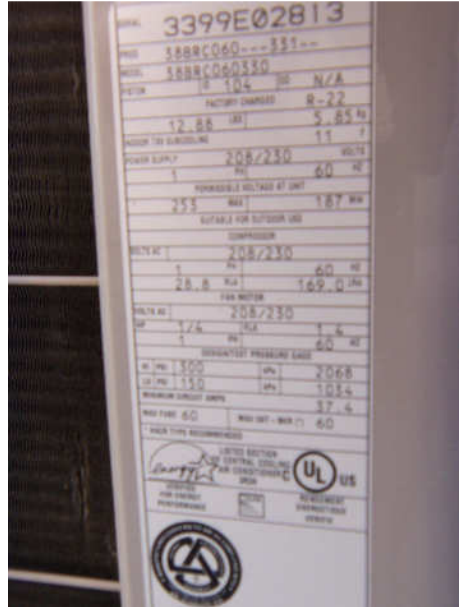
*Comments:* Supply air temp 65.6 degrees, return air temp 86.3 degrees, difference of 20.7 degrees is within accepted range. The fins of the outdoor portion of the air conditioning system along the west side of the house were observed to be damaged and in need of repair. This condition can reduce the efficiency of the system. The auxiliary drain pan installed below the air conditioning system is undersized and should be repaired. The refrigerant lines at the evaporator require additional insulation to avoid condensation outside of drain pan.

The fins of the outdoor portion of the air conditioning system along the west side of the house were observed to be damaged and in need of repair. This condition can reduce the efficiency of the system.

The auxiliary drain pan installed below the of the air conditioning system is undersized and should be repaired

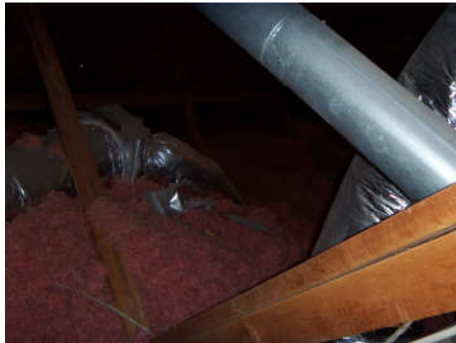
**C. Duct System, Chases, and Vents** *Comments:* Unable to verify that 2nd floor bathroom fans vent through the attic to the exterior as required. Flex duct requires a maximum 4ft span between support bands to prevent sagging.

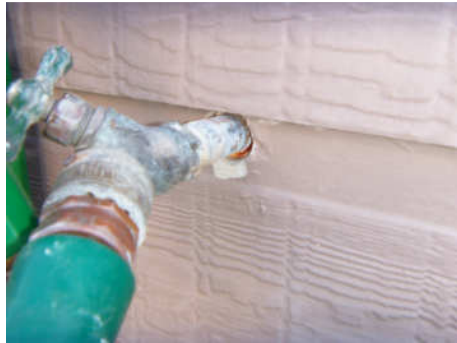
*Comments:* The hose bib along the west side of the house is leaking and should be repaired. Mineral build up was observed at faucets in various locations. This may suggest “hard” water. Continued build up at faucets and within pipes could affect the performance of the supply plumbing system. Water conditioning equipment could be considered. This situation should be monitored. Toilet in 1<sup>st</sup> floor bathroom requires caulk at base.

The hose bib along the west side of the house is leaking and should be repaired.

Mineral build up was observed at faucets in various locations. This may suggest "hard" water. Continued build up at faucets and within pipes could affect the performance of the supply plumbing system. Water conditioning equipment could be considered. This situation should be monitored.
