PROPERTY INSPECTION REPORT

Concerning: 215 Avalanche Ave., Georgetown, TX 78628
(Address or Other Identification of Inspected Property)

By: Jesse W. Bryant TREC#8511 Jan 28, 2011
(Name and License Number of Inspector) (Date)

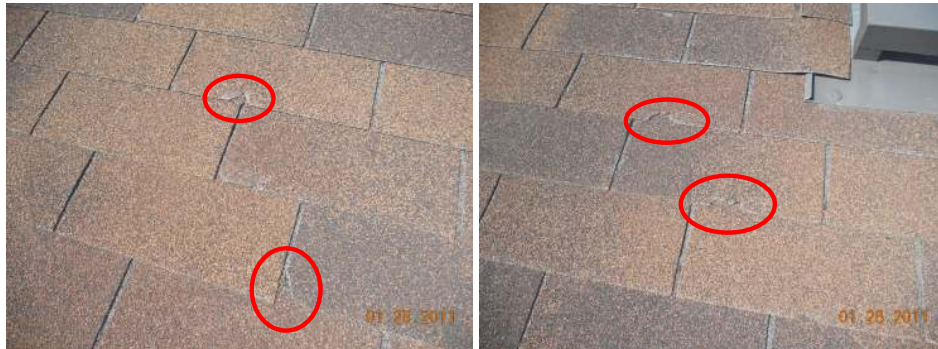
- o There are some slightly damaged shingles on the South slope (worn tab edges). At this time, the damage does not appear to be such that water penetration can occur and no signs of water penetration were noted in the attic. Repairs are recommended as necessary.

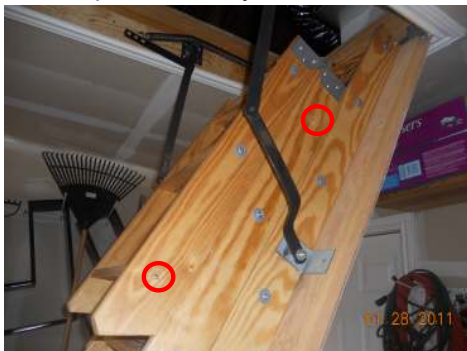
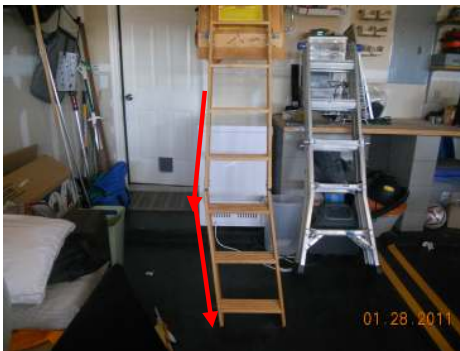
- Some of the attic stair unit hardware is missing (washers and nuts for some of the step rods) and the lower hinges are bent somewhat, which can cause the stair unit to not be completely stable during use. Repairs are recommended for improved safety

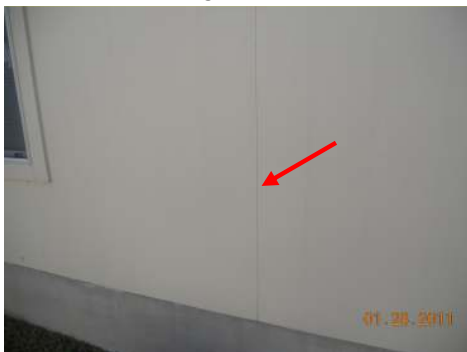
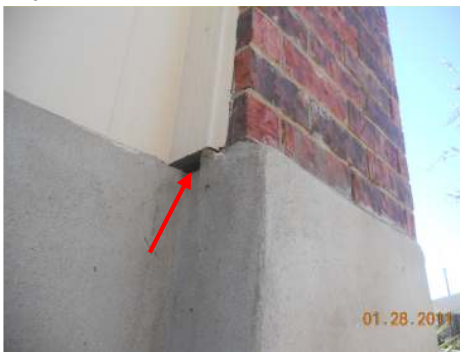
- *FYI: Protecting the home from possible water and insect penetration is very important. One way to achieve this is to ensure that all gaps and openings at the siding and brick exterior of the home remain properly sealed and caulked. Plumbing or other wall penetrations, gaps at the siding and brick joints and any visible points of entry should be properly sealed (with the exception of weep holes in the brick). Annual inspection and maintenance is also recommended as caulking/sealant materials can dry out and shrink over time.*

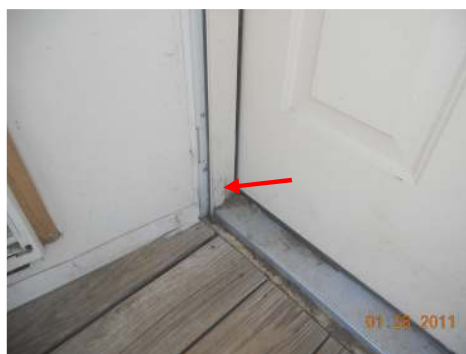
- There is evidence of previous water penetration and trim damage at the rear exterior door. This condition commonly occurs when water runoff from the roof splashes onto the door and jamb after impacting to the patio/deck surface. Once guttering or some other type of drainage diverter is installed over the eave over the doorway, it is recommended that the damaged sections of the door jamb material be repaired in order to prevent future water penetration.

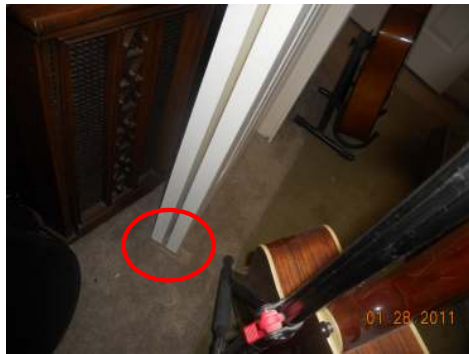
- The sliding closet door track guides are missing in the Southwest bedroom. The installation of a new track guide at the floor is recommended in order to prevent the doors from swinging or rubbing against each other during use.

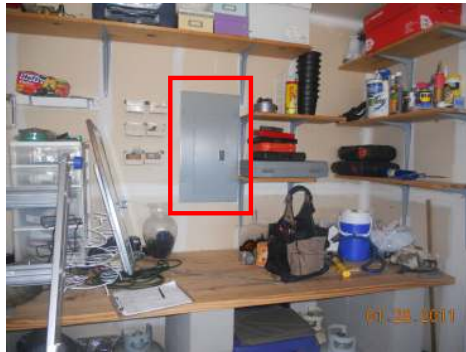
- There is inadequate clearance at the front and sides of the subpanel box in the garage. All electrical panel boxes should have a 36” deep by 30” wide by 6 ½’ high free area in front of the access. This clearance should be maintained for improved safety.
