## PROPERTY INSPECTION REPORT

**Prepared For:** Jon Hopkins  
(Name of Client)

**Concerning:** 122 Summers Green, Georgetown Texas 78633  
(Address or Other Identification of Inspected Property)

**By:** Ken Cofer # 20262 09-22-11  
(Name and License Number of Inspector) (Date)

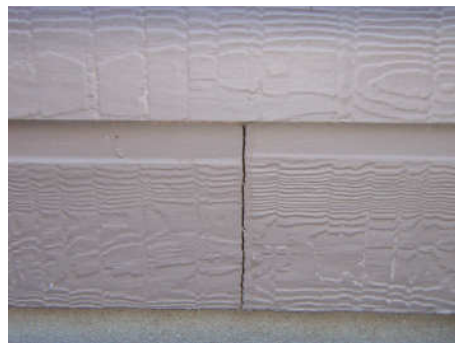
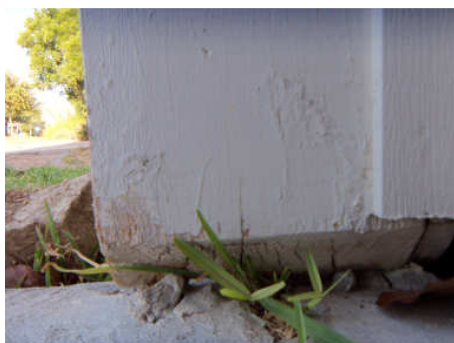
**E. Walls (Interior & Exterior)** *Comments:* Minor cracks were noted on interior walls in various locations. This condition is mainly cosmetic in nature and should be patched. **TREC LIMITATIONS:** The inspector is not required to report cosmetic damage or the condition of floor, wall, or ceiling coverings; paints, stains, or other surface coatings; cabinets; or countertops, or provide an exhaustive list of locations of water penetrations. Caulking or sealant separated or missing in multiple areas regarding the exterior siding, around penetrations such as vents, electrical wiring, window frames, light fixtures and hose bibs. Facia/trim boards are water damaged in several areas. Vent penetration requires weather protection in the form of a damper as well as 1/4" to 1/2" mesh screen at termination. Exterior cement board siding does not comply with manufacturers installation guidelines on south side of structure. Manufacturer requires a minimum 2" separation from bottom edge of siding to roofing. Indication of water penetration and damage to the gable vent and window frames on south side of structure. Soffit vent on eastside of structure appears to be loose.

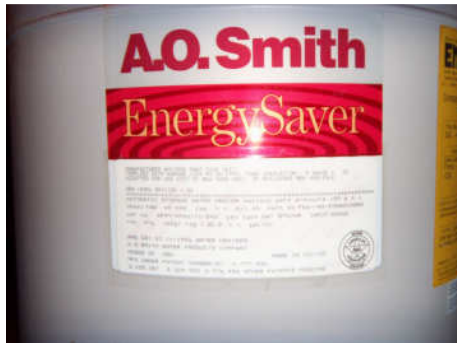
**C. Water Heating Equipment**  
*Energy Source:* Gas  
*Capacity:* 40 gal  
*Comments:*

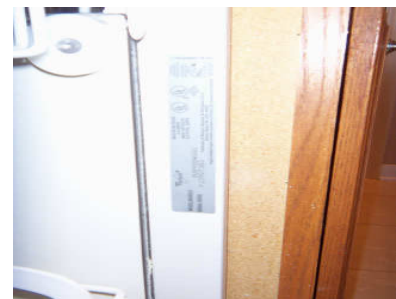
**D. Ranges, Cooktops, and Ovens** *Comments:* Anti-tip device not located.
